**TO:** Joe Brogan, Chief of Stormwater Programs  
York County, Virginia  
Department of Public Works (DPW)

**FROM:** AH Environmental Consultants, Inc. (AH)

**SUBJECT:** Preliminary Assessment of Queens Lake Stream Improvements

**DATE:** 23 November 2022

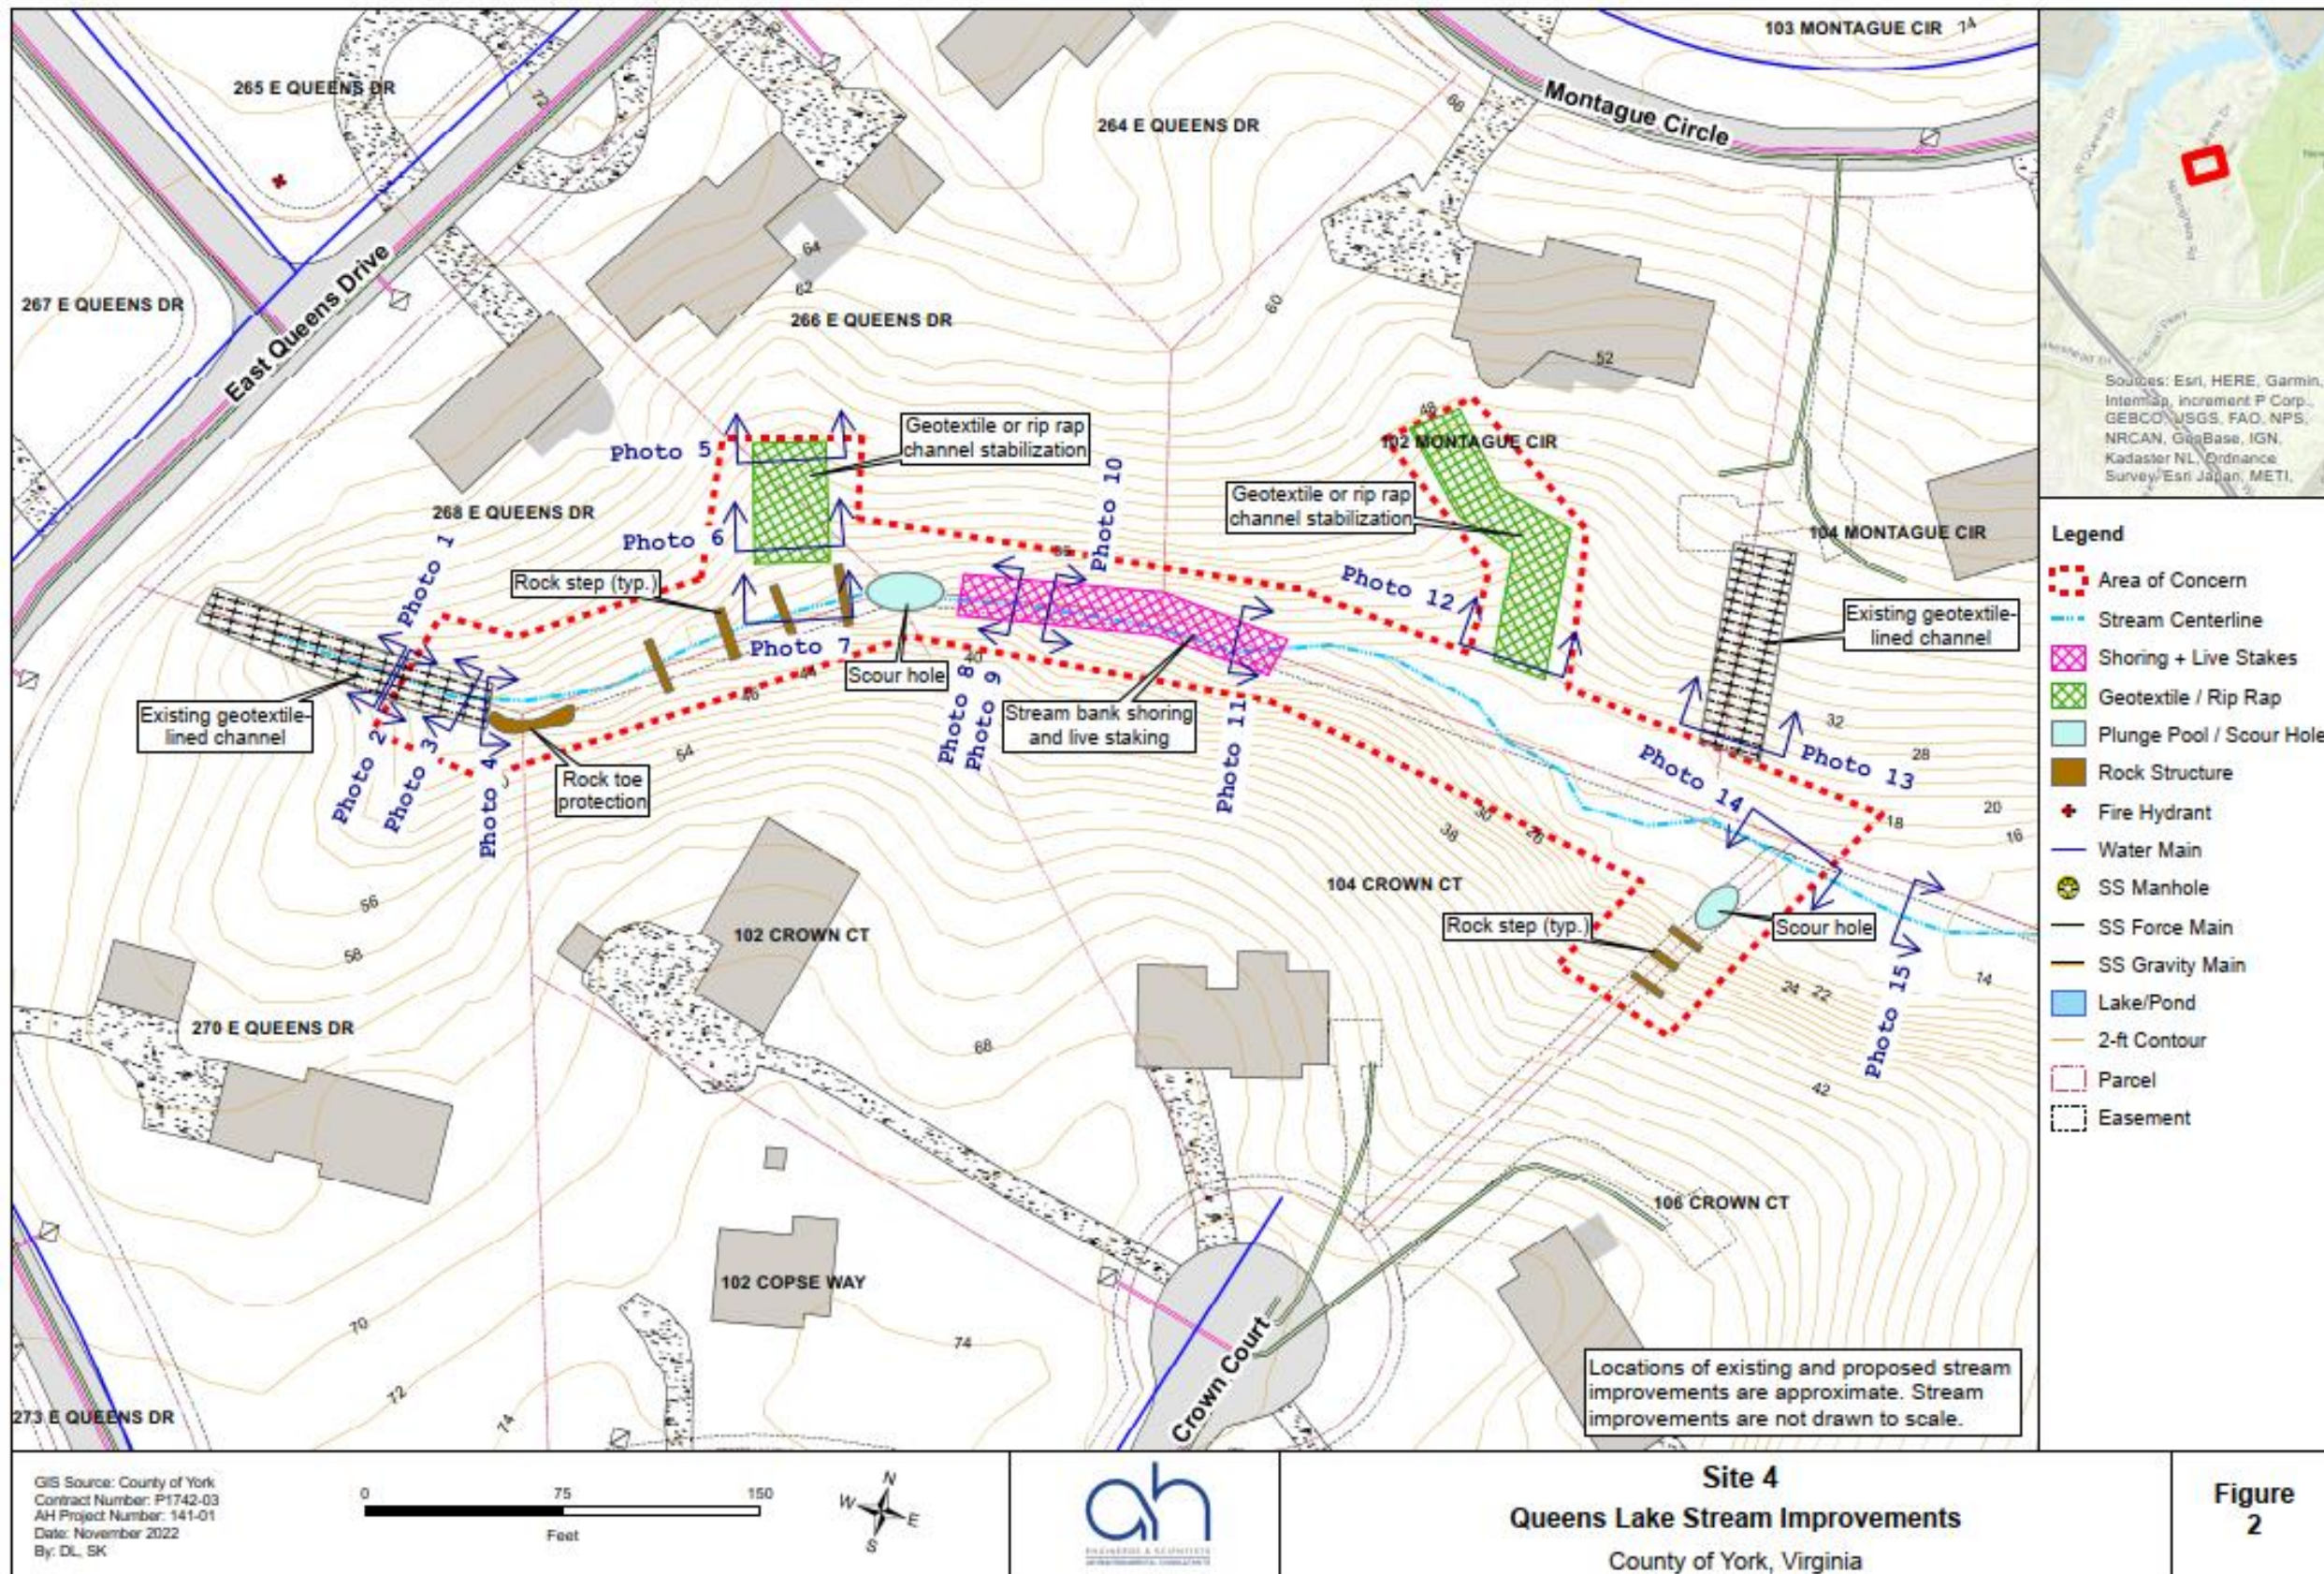
Site 4 is located east of East Queens Drive between Crown Court and Montague Circle. The area of concern begins where previous efforts to control erosion end (i.e., existing geotextile-line swale). The site includes various forms of erosion including channel, stream bank, and slope erosion. Significant slope erosion was observed behind 266 and 268 East Queens Drive and 102 Montague Drive. **Section 3.1.1** provides Site 4 photographs capturing these conditions.

**Figure 2** identifies the primary areas of concern, location of photographs, and preliminary recommended corrective actions. Site 4 requires approximately 400 to 500 linear feet (LF) of restoration activities, including the following:

- Approximately 2 plunge pools / scour holes
- Rock toe protection
- 5-10 rock steps (and/or cross vanes)
- Up to 200 LF of bank shoring and live stakes
- Up to 200 LF of geotextile or rip rap channel stabilization
- Up to 12 large (>12-inch (") diameter) trees for potential removal

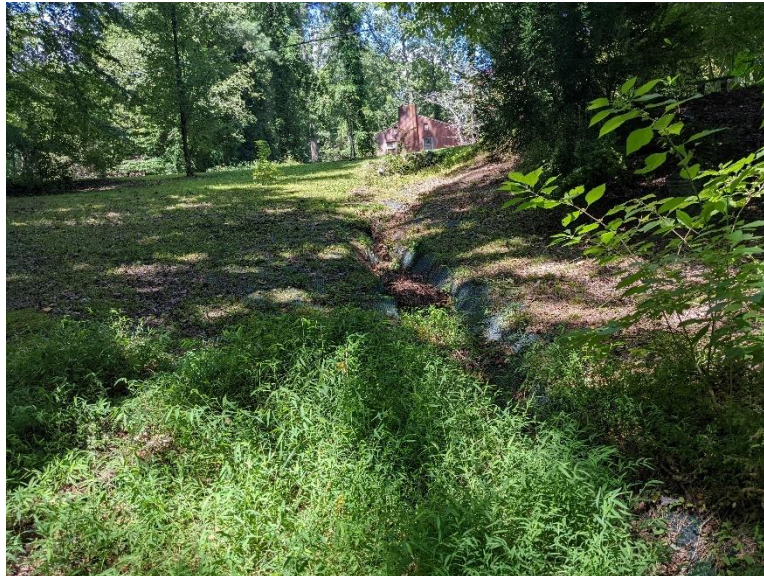
**Site 4, Photo 1: Existing Geotextile Lined Channel from East Queens Drive (Looking Upstream (West))**

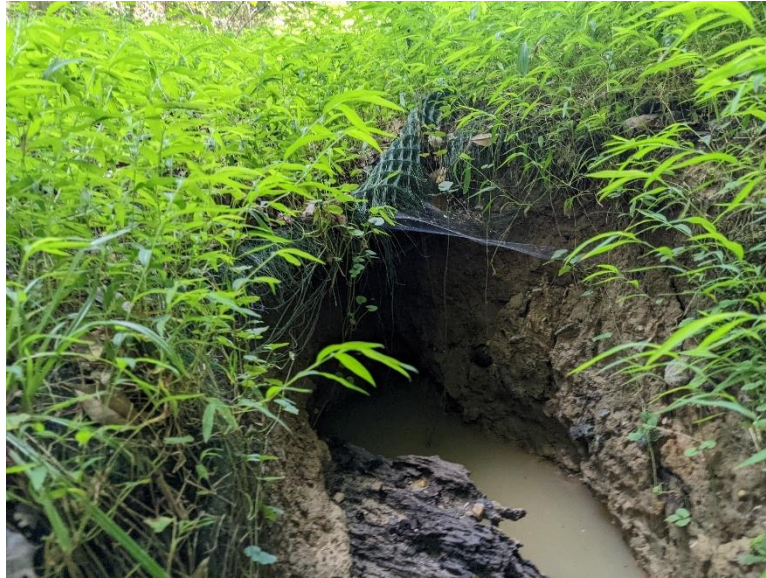
**Site 4, Photo 3: End of Existing Geotextile Lined Channel (Looking Upstream (West))**

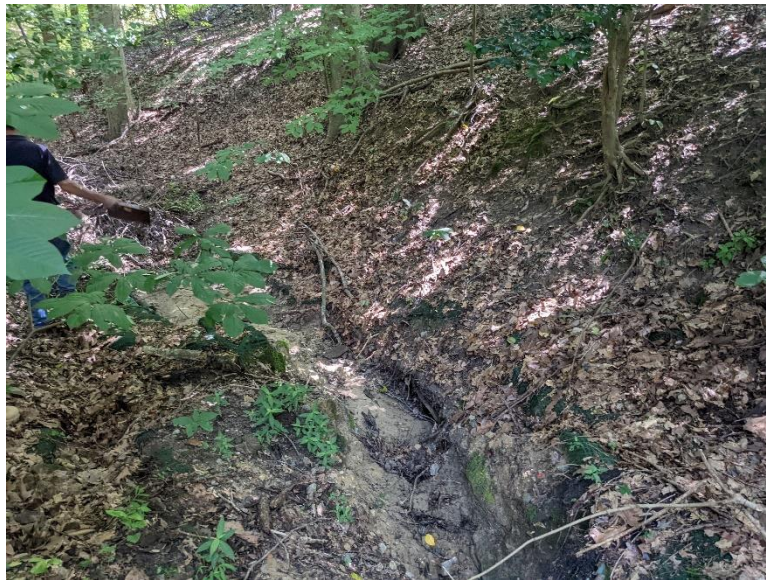
**Site 4, Photo 4: Continuing into the woods (Looking Downstream (East))**

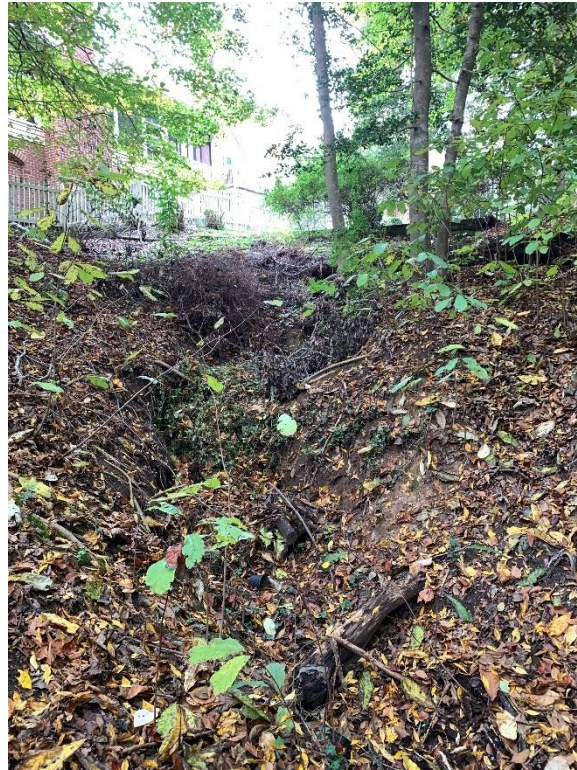
**Site 4, Photo 5: Slope Erosion behind 266 East Queens Drive (Top of Slope, Looking North)**

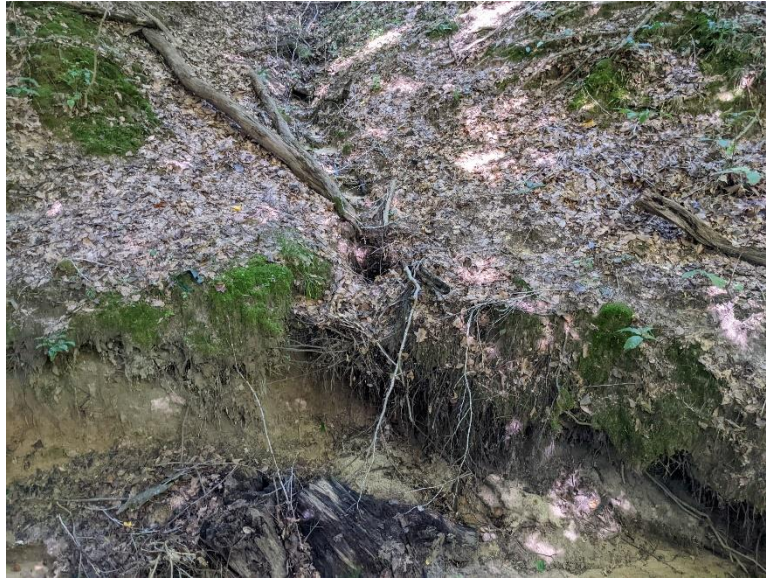
**Site 4, Photo 7: Slope Erosion behind 266 East Queens Drive (Tie-in to Primary Stream, Looking North)**

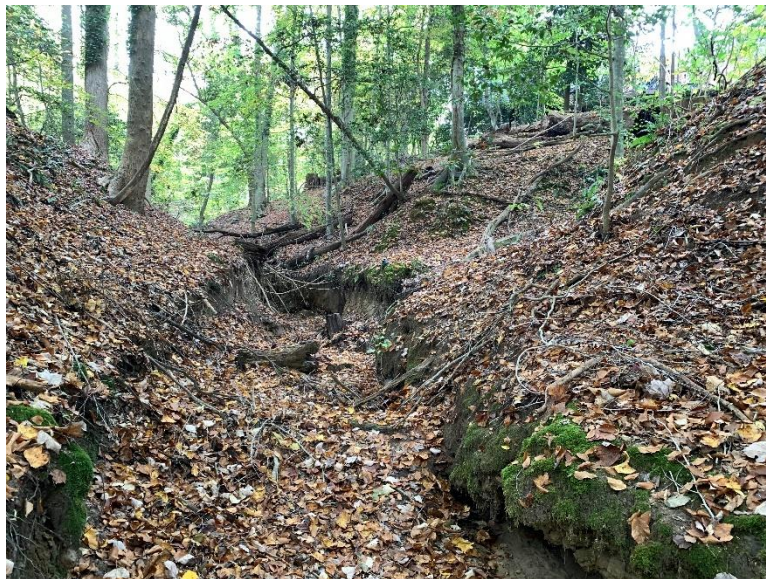
**Site 4, Photo 8: Stream Erosion (Looking Upstream (West))**

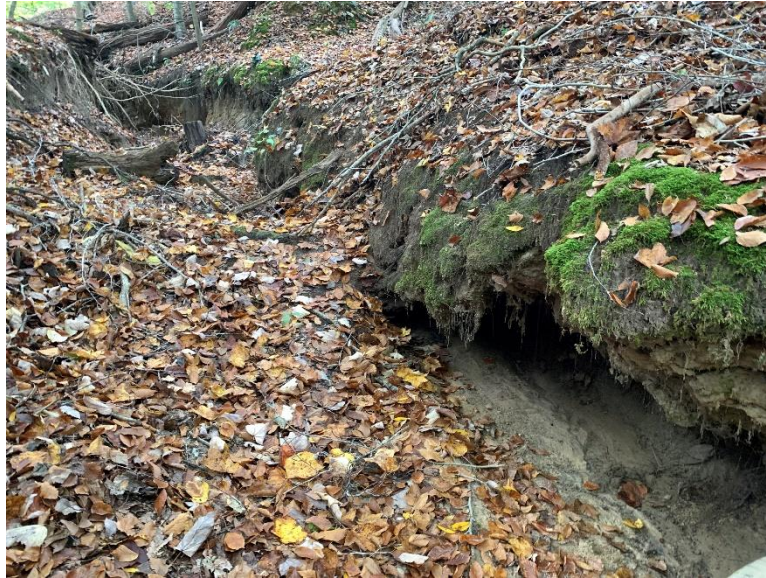
**Site 4, Photo 9: Stream Erosion (zoom-in) (Looking Upstream (West))**

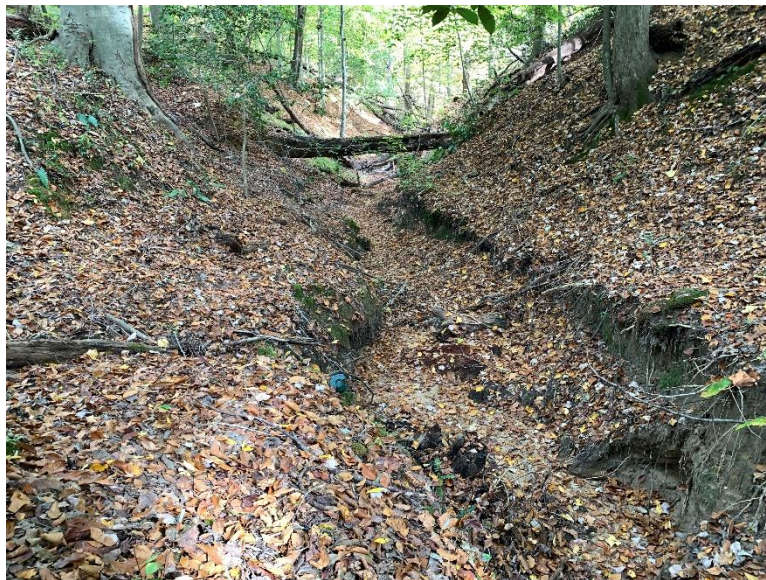
**Site 4, Photo 10: Stream Erosion (Looking Downstream (East))**

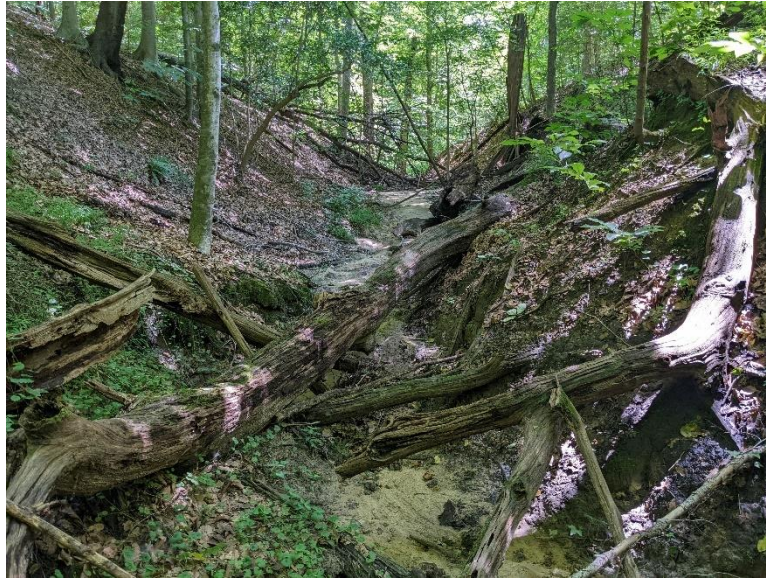
**Site 4, Photo 11: Continuation of Stream with Debris (Looking Downstream (East))**

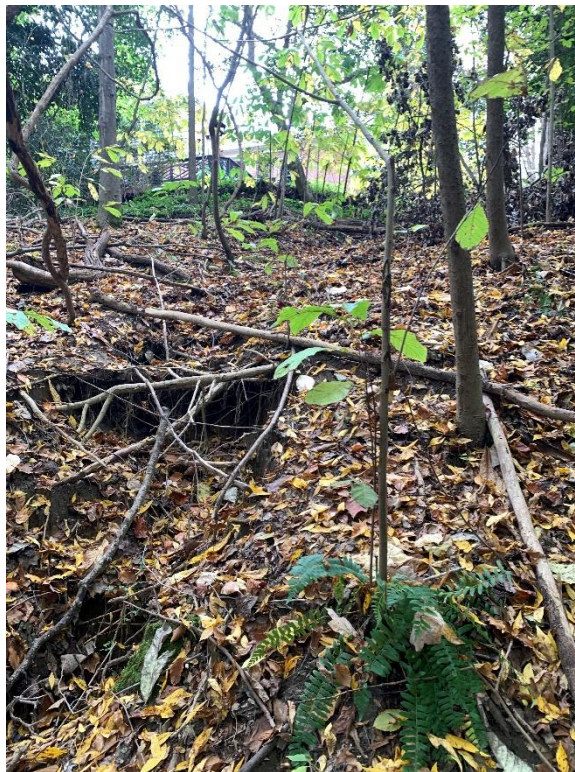
**Site 4, Photo 12: Slope Erosion behind 102 Montague Circle**

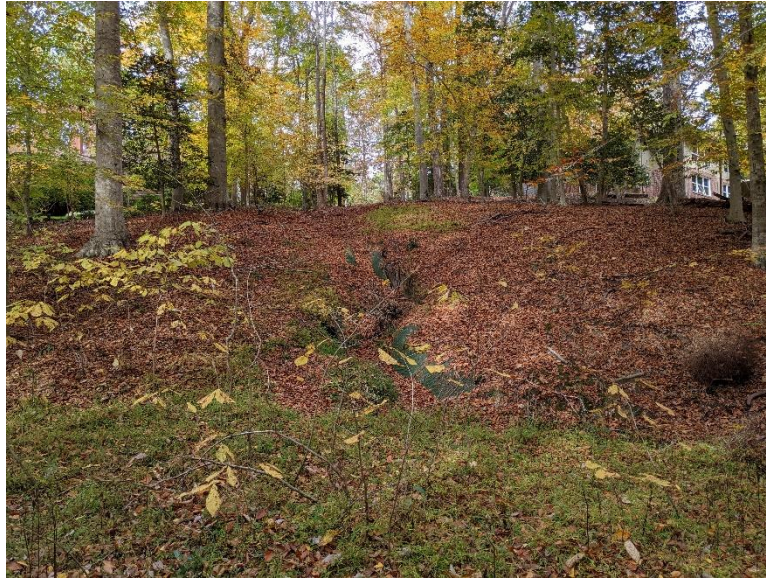
**Site 4, Photo 13: Existing Geotextile Lined Channel at 104 Montague Circle (Bottom of Slope, Looking North)**

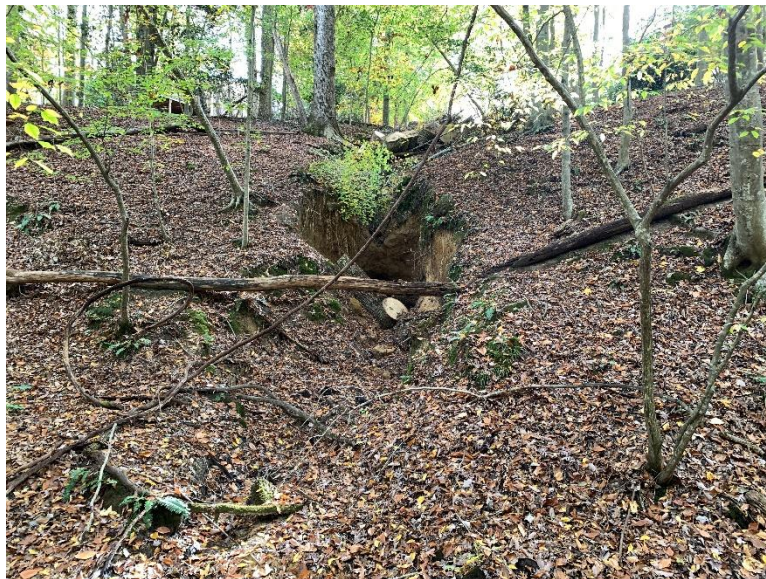
**Site 4, Photo 14: Severe Erosion between 104 and 106 Crown Court (Bottom of Slope, Looking South)**

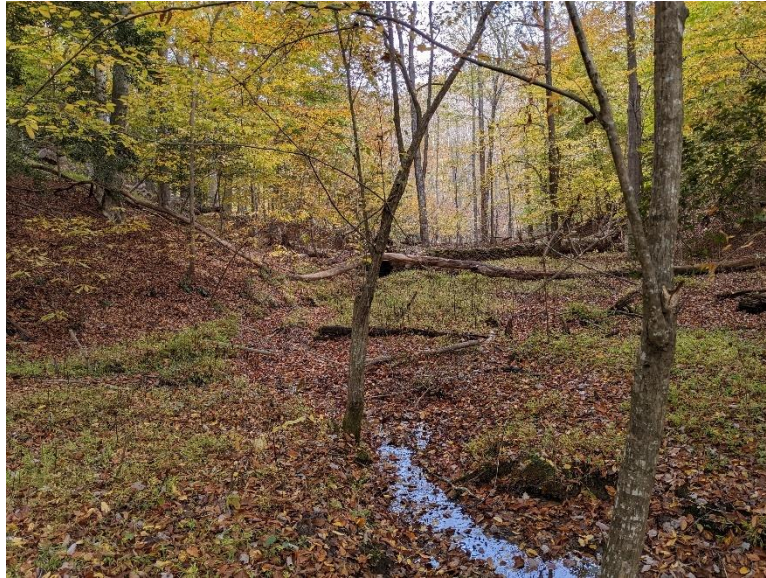
**Site 4, Photo 15: View of Stream (Looking Downstream (East))**

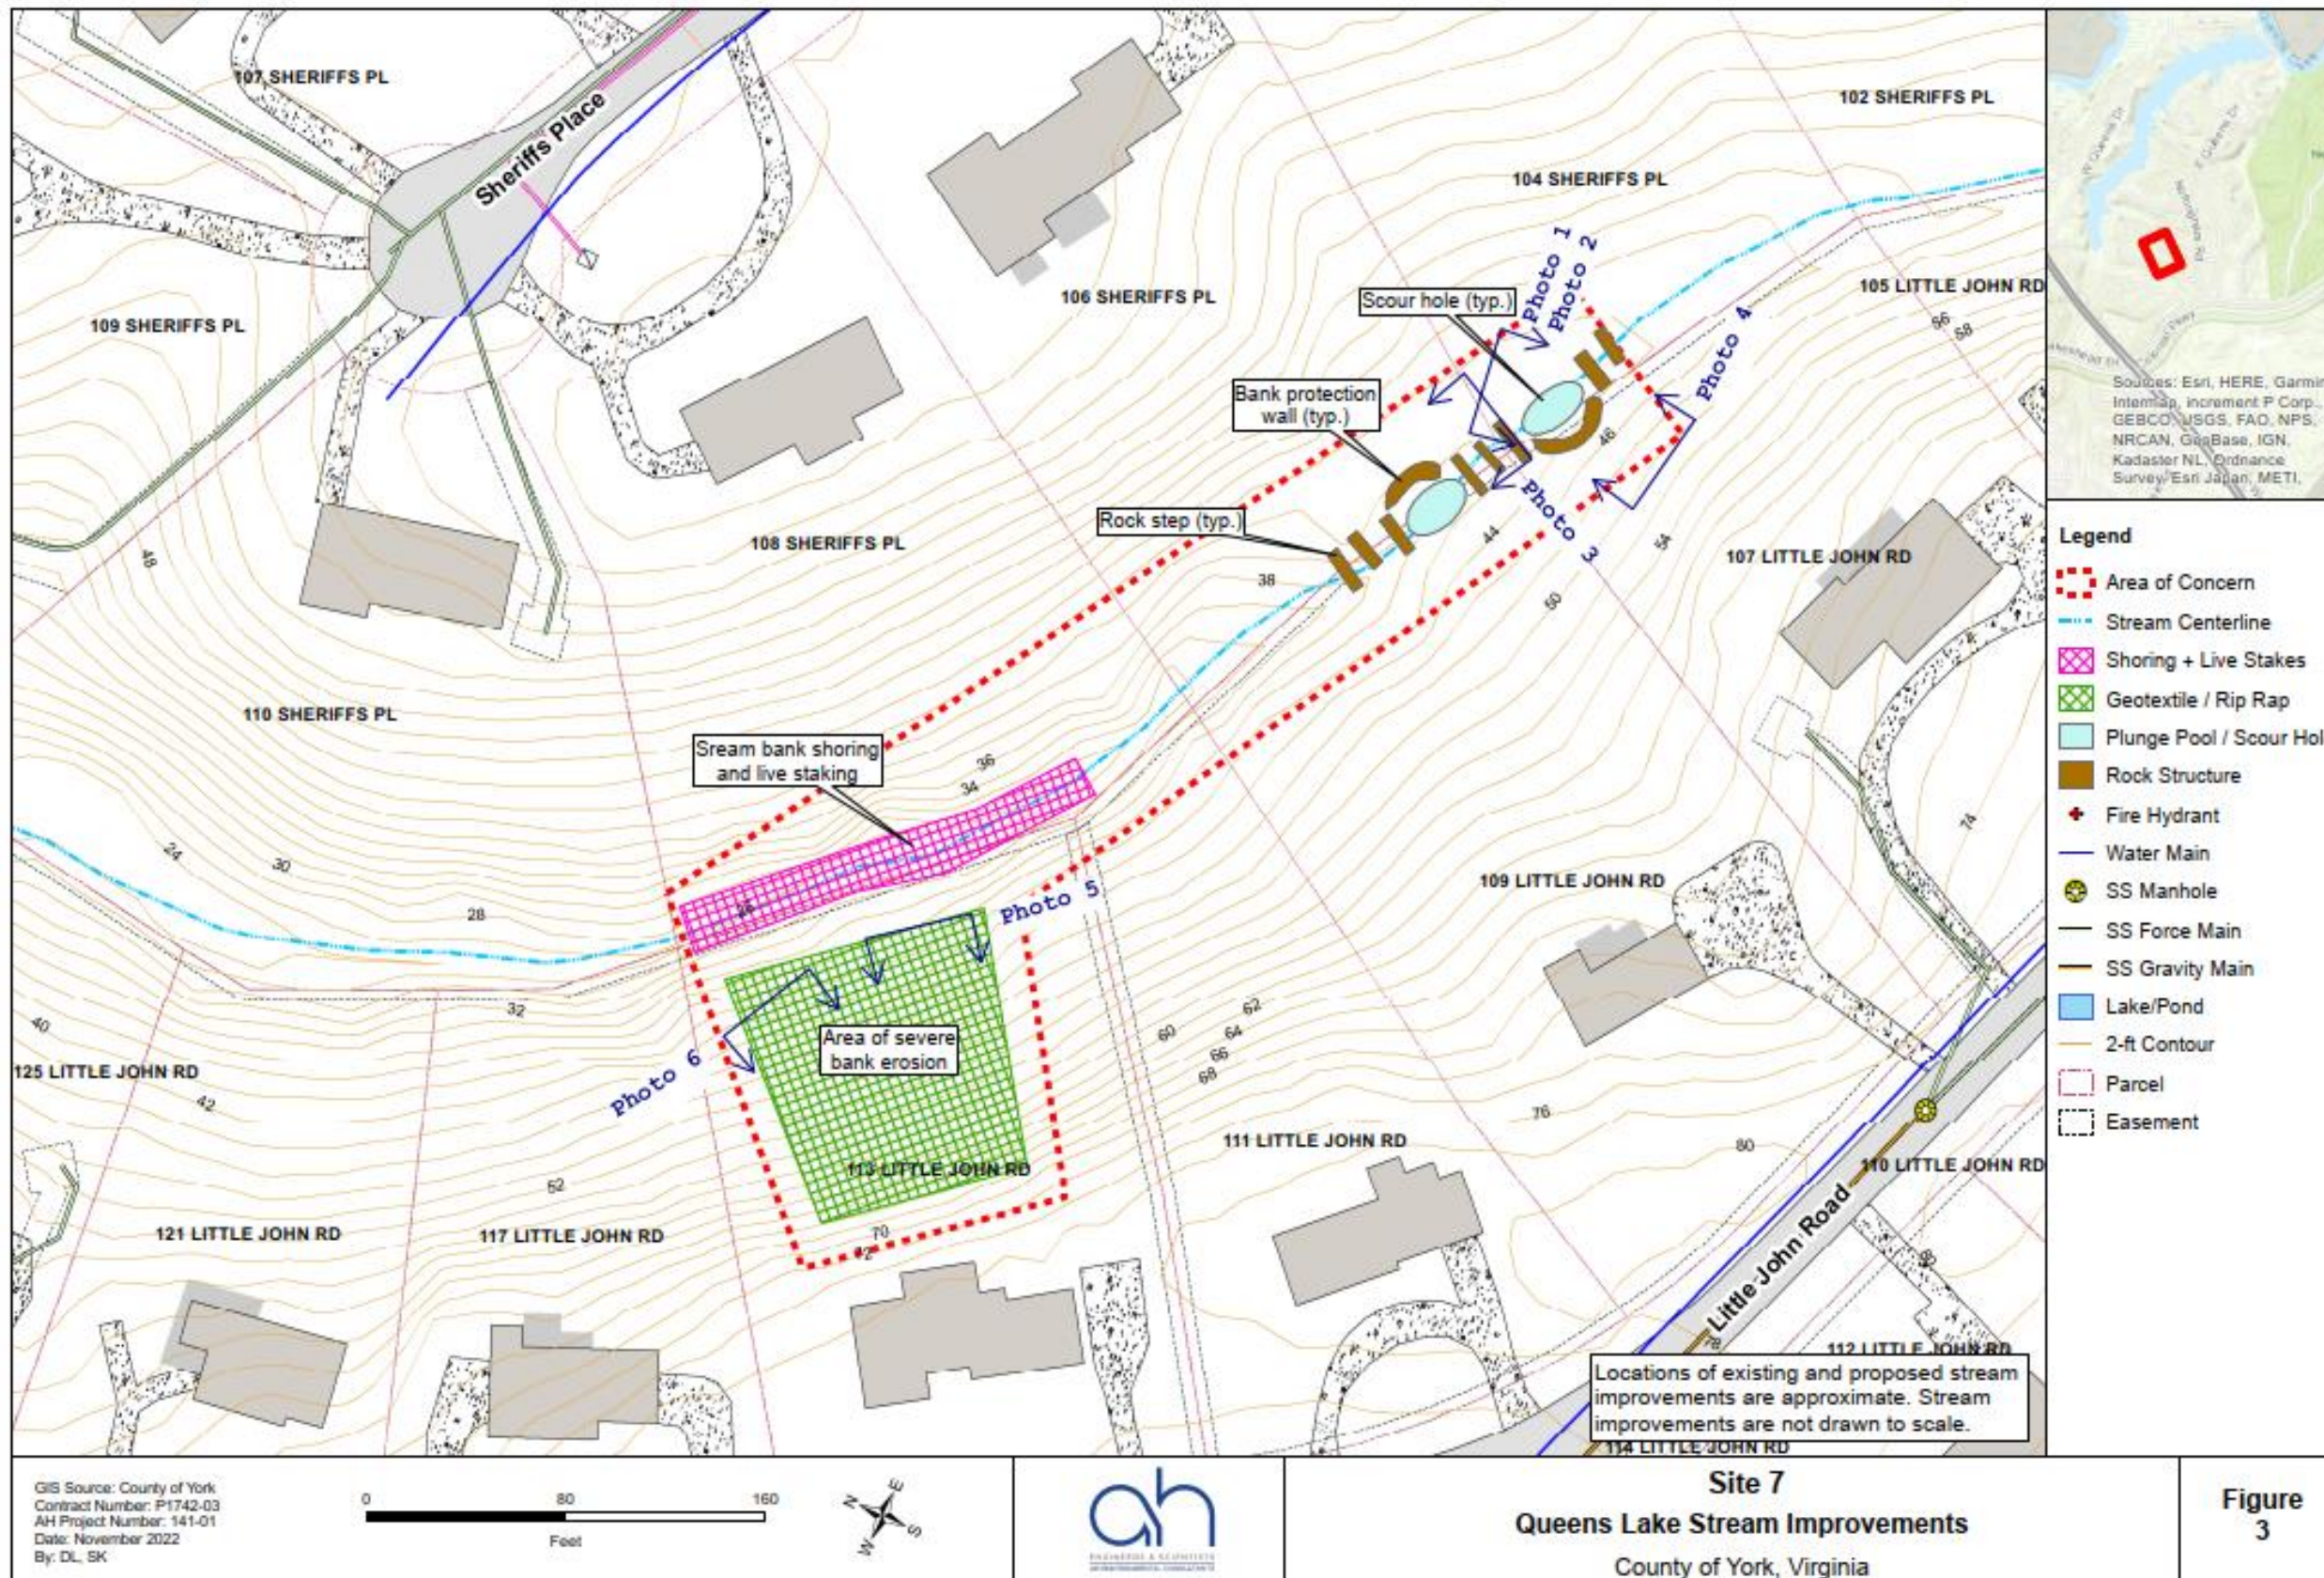
Site 7 is located between Sheriffs Place and Little John Road. The site includes approximately 150 LF of severe gully erosion, an area of severe slope erosion (behind 113 Little John Road), and approximately 200 LF of moderate stream bank incision. **Section 3.2.1** provides Site 7 photographs capturing these conditions.

**Figure 3** identifies the primary areas of concern, location of photographs, and preliminary recommended corrective actions. Site 7 requires approximately 400-500 LF of restoration activities, including the following:

- 2-3 plunge pools / scour holes
- 2 bank protection walls (stacked stone or other material)
- 8-10 rock steps (and/or cross vanes)
- Up to 250 LF of bank shoring and live stakes
- Approximately 10,000 square feet (SF) of steep slope stabilization
- Up to 6 large (>12" diameter) trees for potential removal

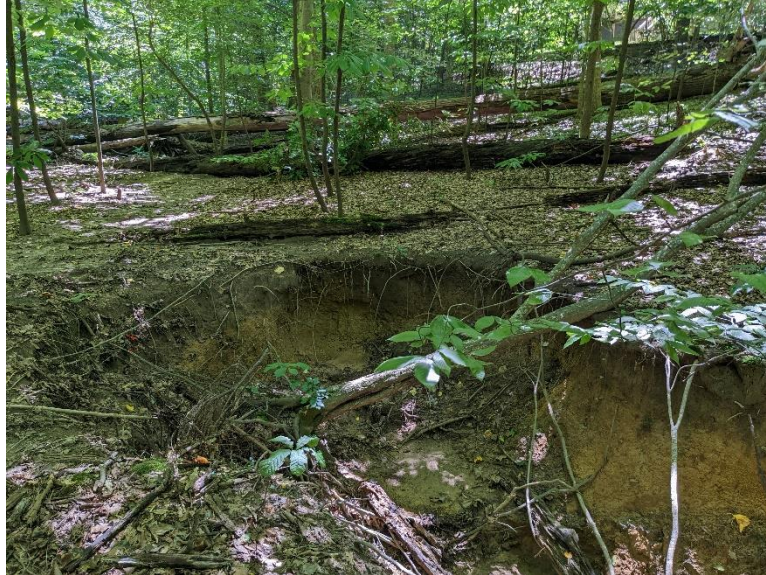
**Site 7, Photo 1: Channel Erosion (Looking Upstream (Southeast))**

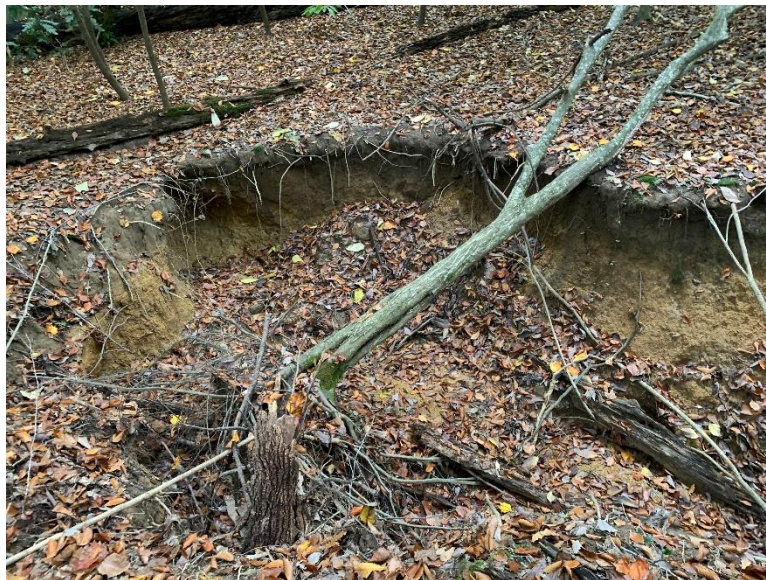
**Site 7, Photo 2: Channel Erosion Zoom-In (Looking Upstream (Southeast))**

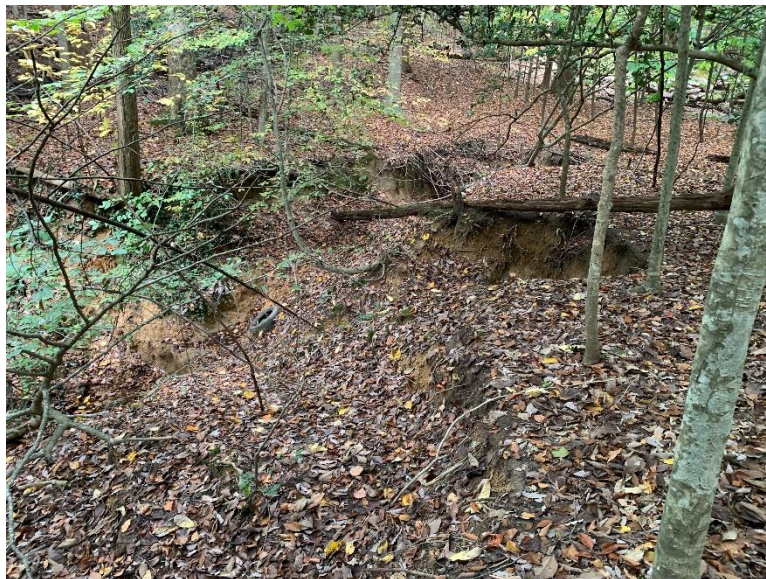
**Site 7, Photo 4: Channel Erosion (Looking Northeast)**

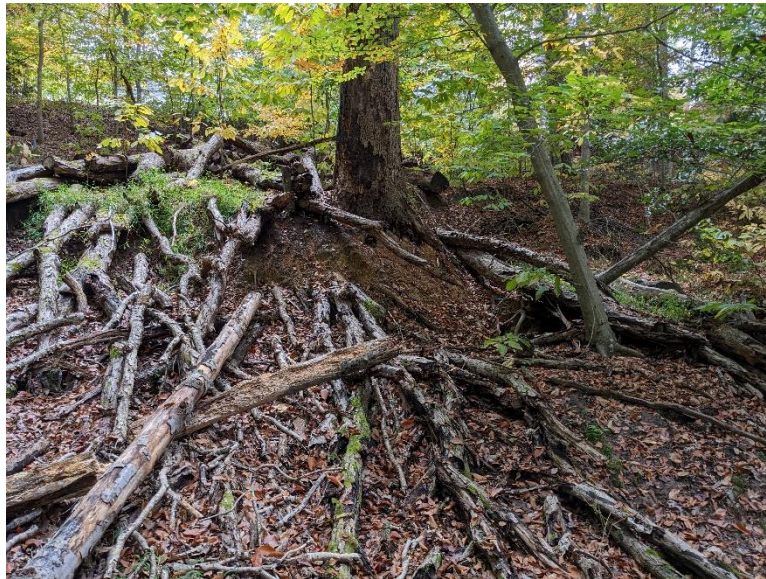
**Site 7, Photo 6: Severe Slope Erosion (Southwest toward 113 Little John Road)**

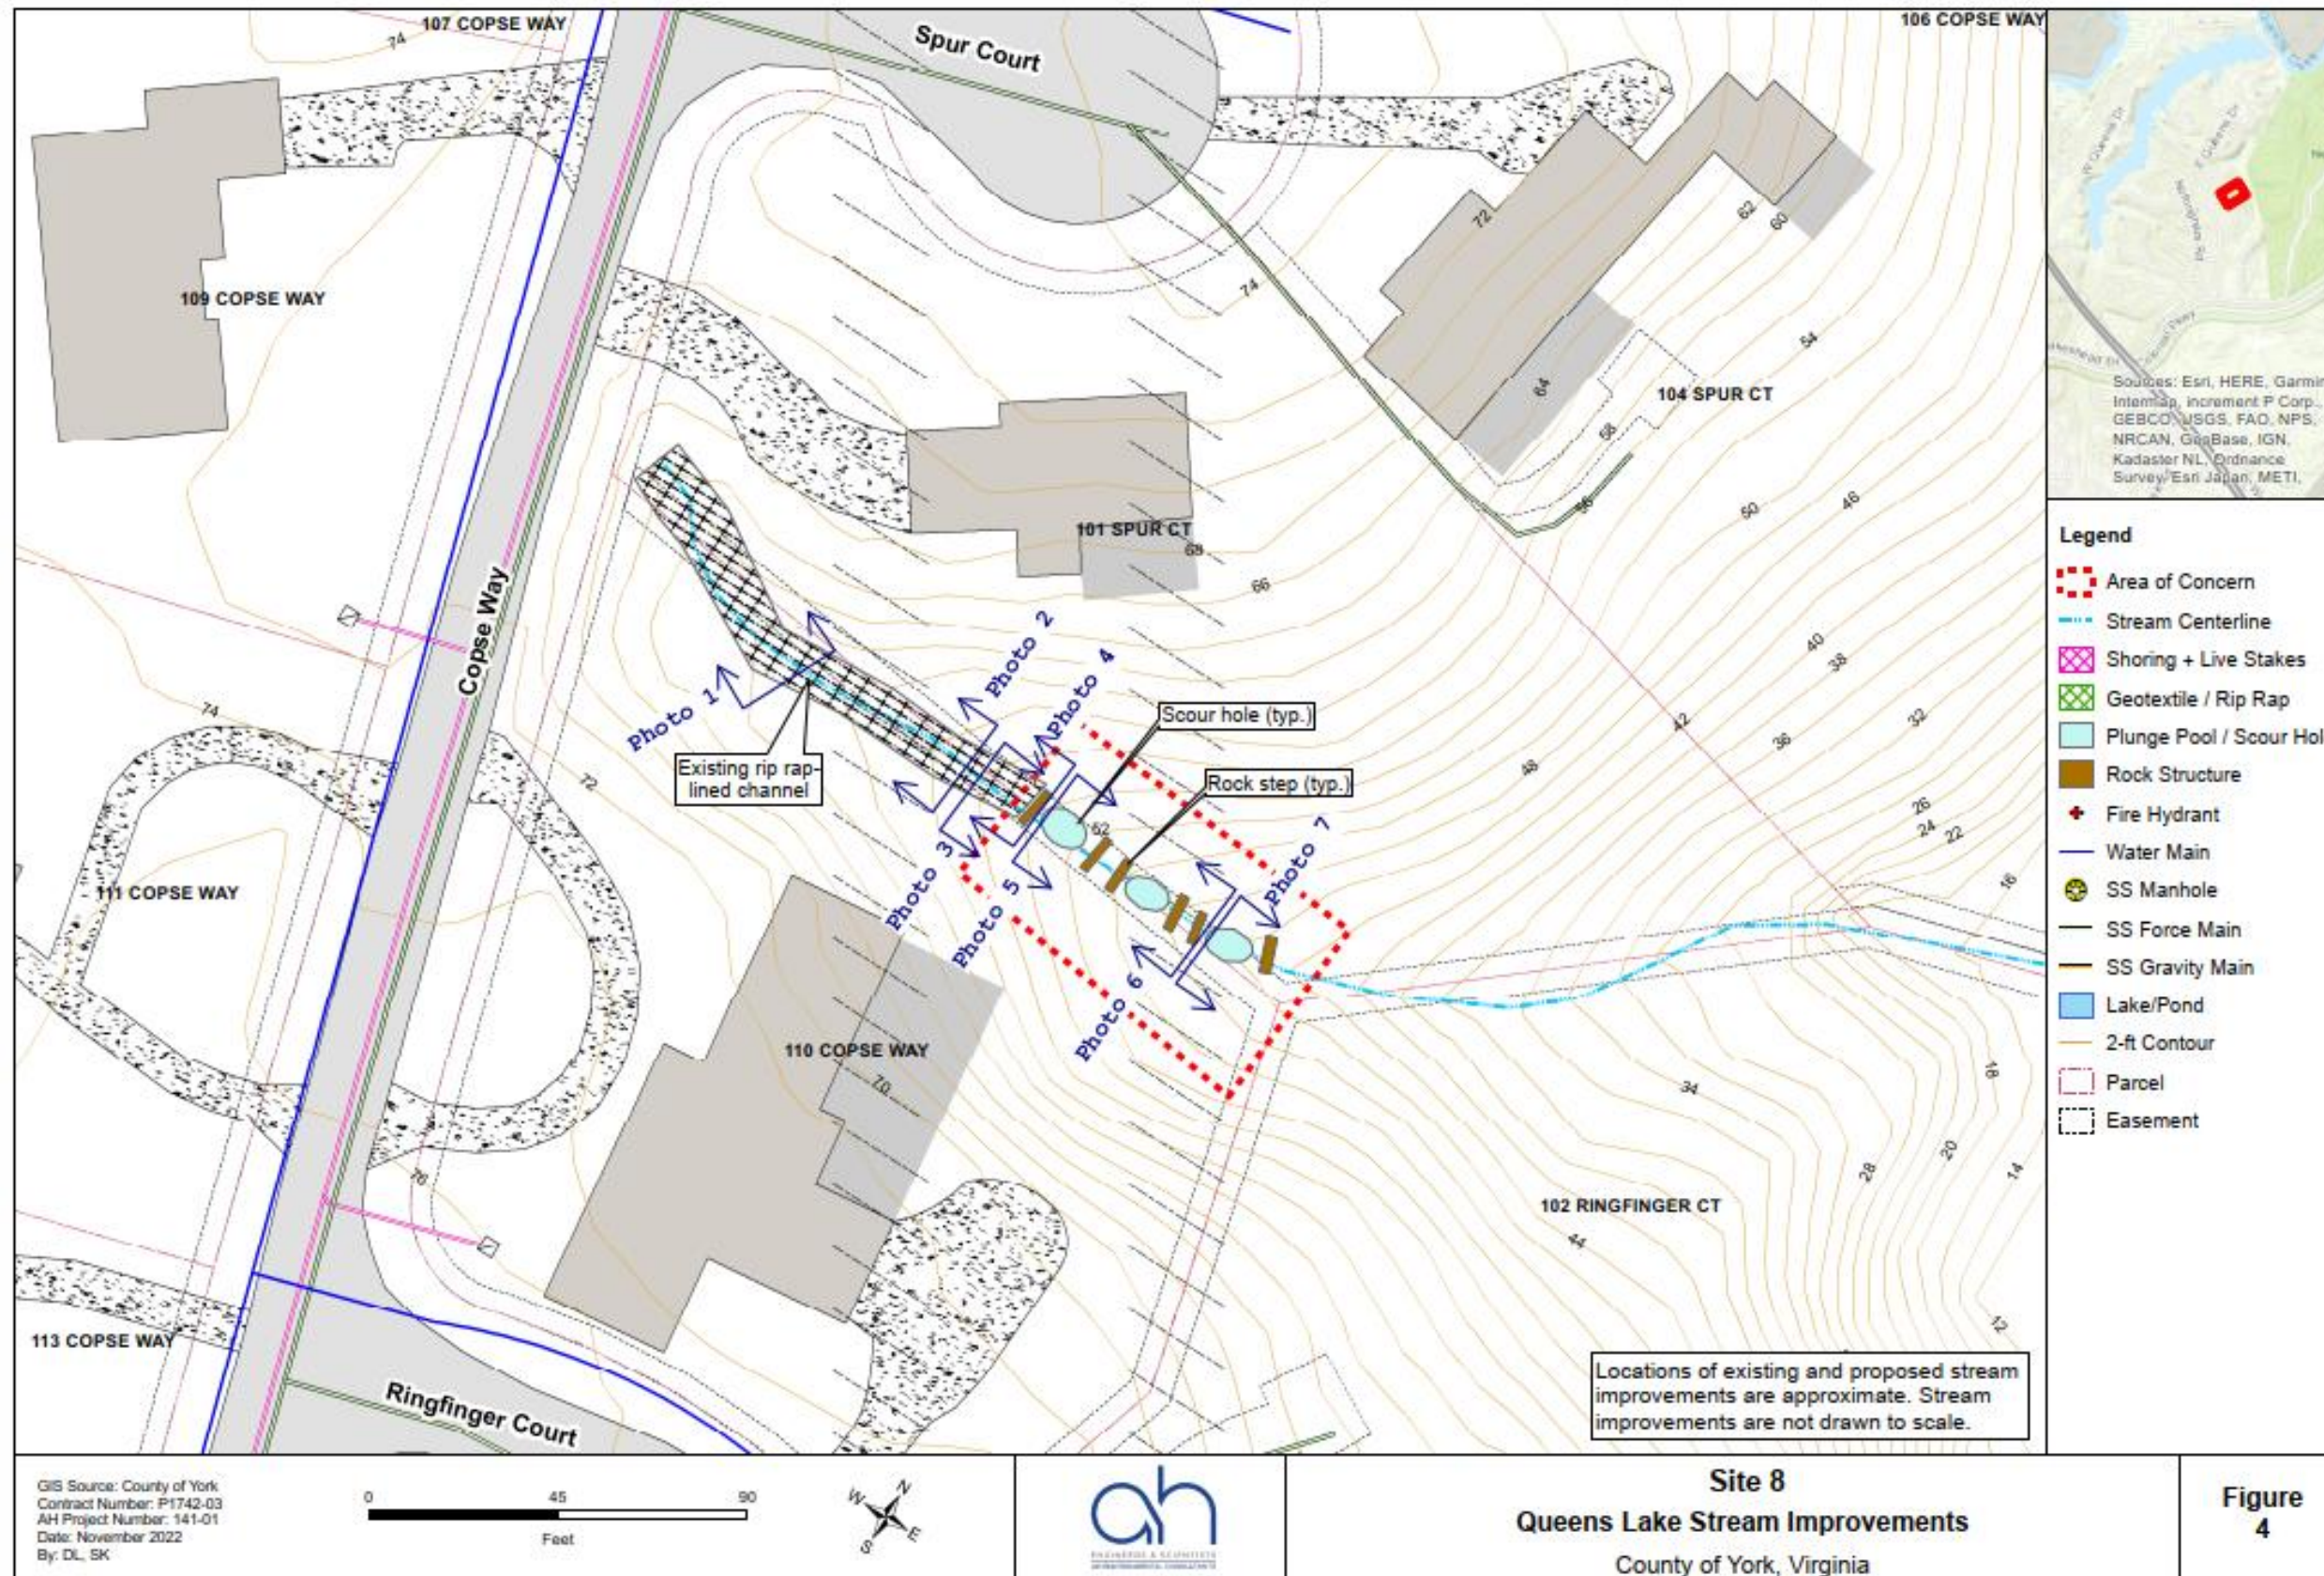
Site 8, located between 101 Spur Court and 110 Copse Way, comprises an approximately 120-LF reach of channel erosion immediately downstream of an existing rip rap-lined stormwater swale. Gully erosion is occurring and migrating in the upstream direction. The gully is approximately 13 feet deep at its deepest point. The top width of the gully ranges from 4 to 10 feet. **Section 3.3.1** contains Site 8 photographs capturing these conditions.

**Figure 4** identifies the primary areas of concern, location of photographs, and preliminary recommended corrective actions. Site 8 requires approximately 120 LF of restoration activities, including the following:

- 6-10 rock steps (and/or cross vanes)
- 2-3 scour holes/plunge pools extending from the end of the upstream existing rip rap stabilization to the downstream end of the eroded channel section.

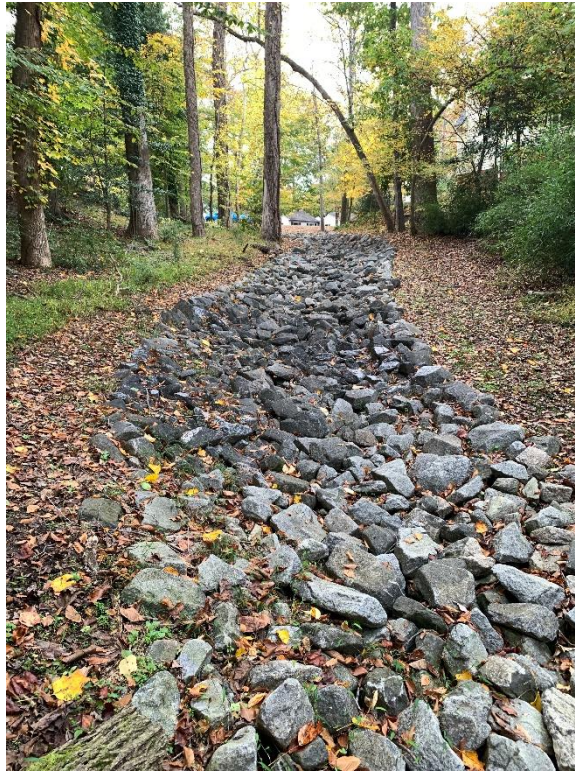
**Site 8, Photo 1: Existing Rip Rap (Looking Upstream to Copse Way)**

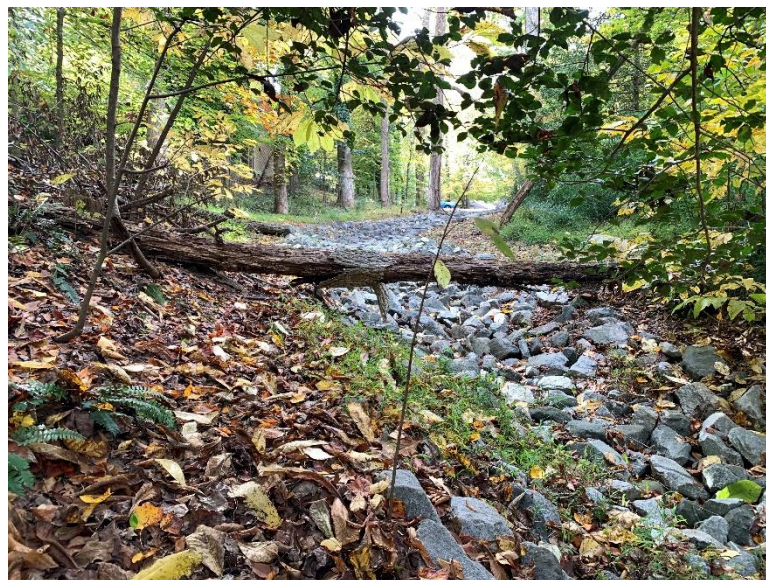
**Site 8, Photo 2: Existing Rip Rap (Looking Upstream to Copse Way)**

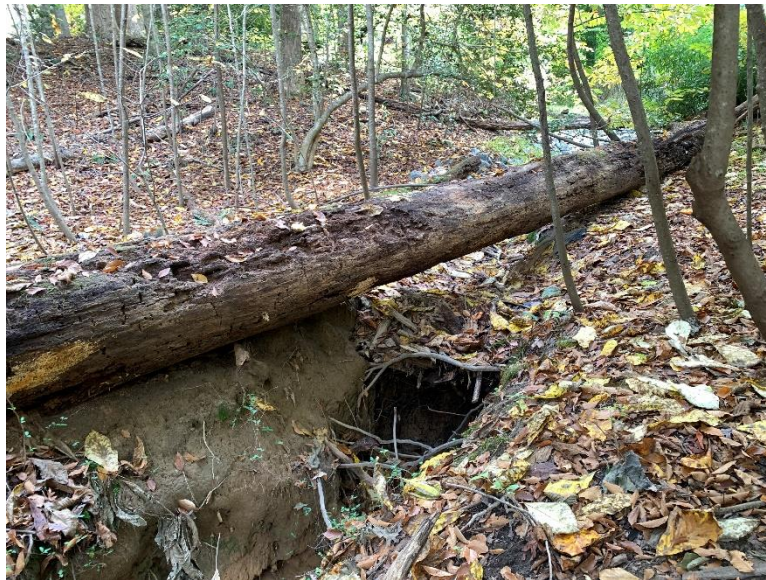
**Site 8, Photo 4: Beginning of Channel Erosion (Looking Upstream)**

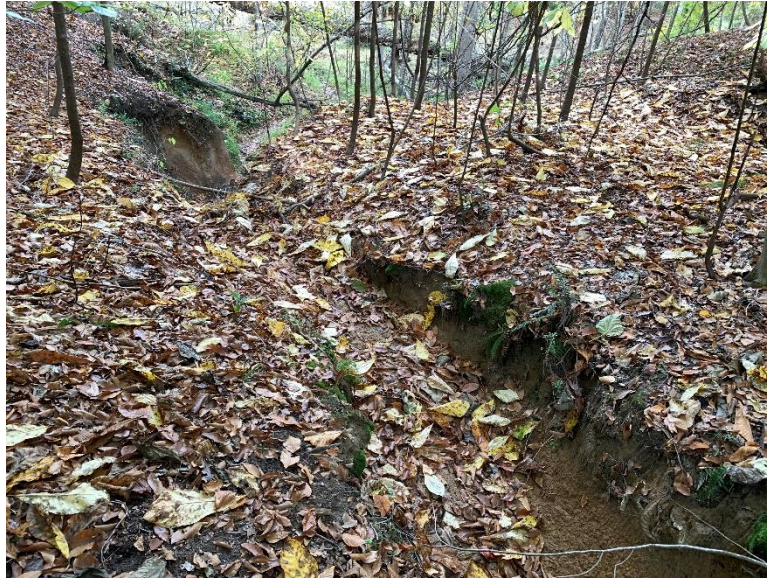
**Site 8, Photo 5: Channel Erosion (Looking Downstream)**

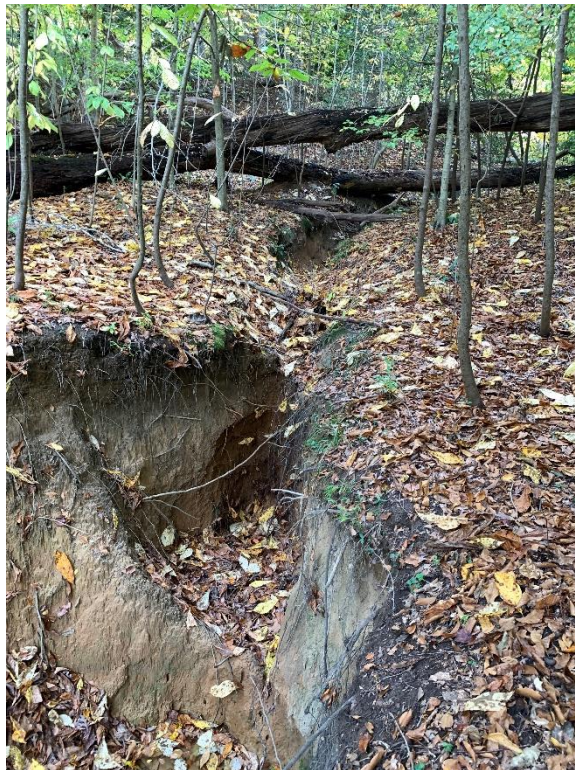
**Site 8, Photo 6: Channel Erosion (Looking Upstream)**

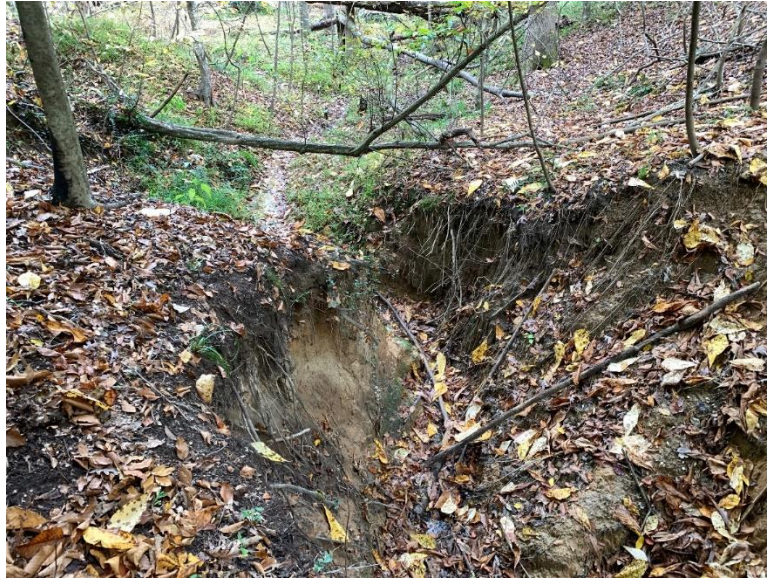
**Site 8, Photo 7: Channel Erosion (Looking Downstream)**
