**TO:** Joe Brogan, Chief of Stormwater Programs  
York County, Virginia  
Department of Public Works (DPW)

**FROM:** AH Environmental Consultants, Inc. (AH)

**SUBJECT:** Preliminary Assessment of Queens Lake Stream Improvements

**DATE:** 23 November 2022

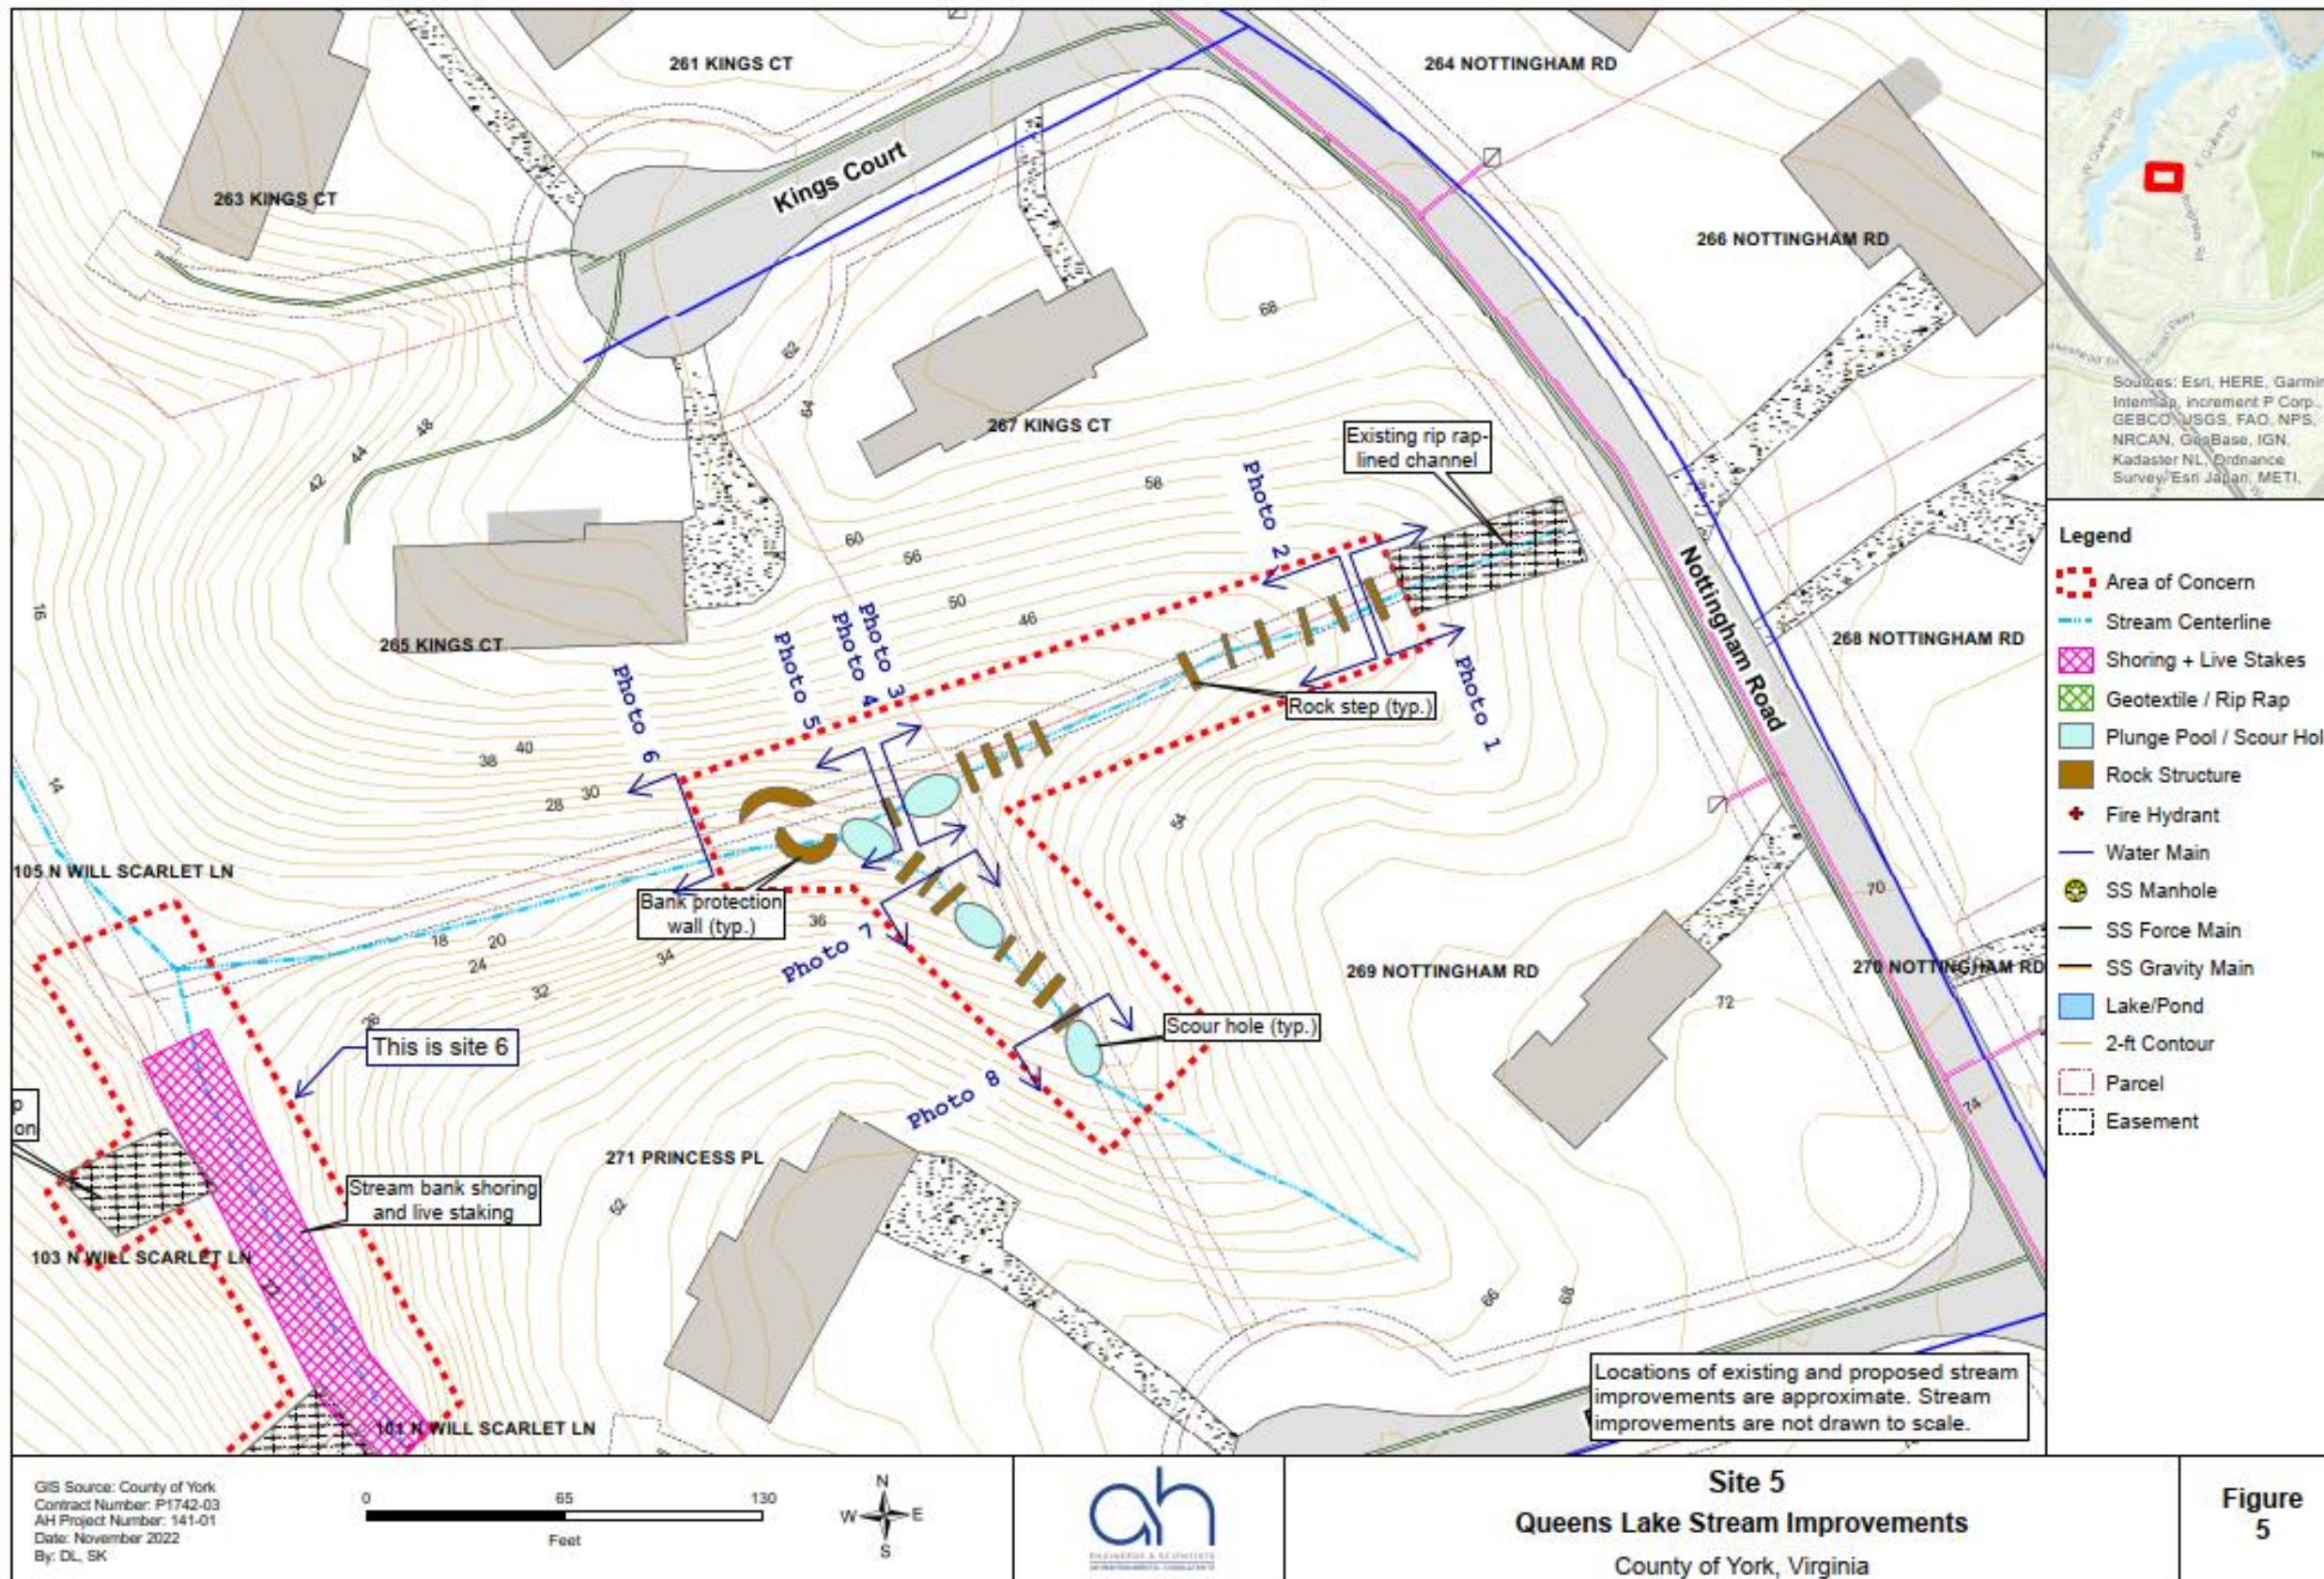
Site 5, located west of Nottingham Road between Kings Court and Princess Place, comprises the confluence of two channels and the reaches approximately 200 feet upstream of the confluence point. Moderate stream bank incision was observed on the reach downstream of Nottingham Road. In the vicinity of the confluence point, severe gully erosion was observed, particularly associated with the channel northeast of 271 Princess Place. There are also several fallen trees, including one that fell between the August and November 2022 site visits. **Section 3.4.1** presents Site 5 photographs capturing these conditions.

**Figure 5** identifies the primary areas of concern, location of photographs, and preliminary recommended corrective actions. Site 5 requires approximately 400 LF of restoration activities, including the following:

- Approximately 4 plunge pools / scour holes
- 2 bank protection walls (stacked stone or other material)
- Up to 20 rock steps (and/or cross vanes)
- Up to 500 LF of bank shoring and live stakes
- Up to 8 large (>12" diameter) trees for potential removal

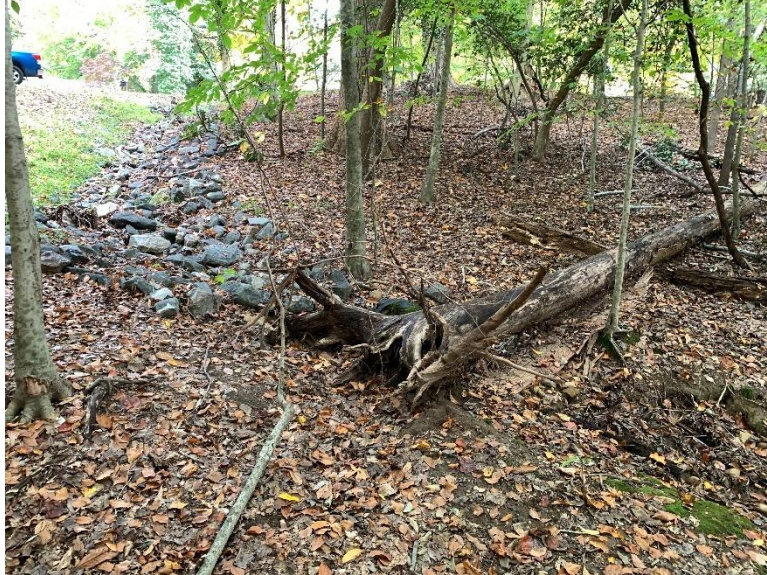
**Site 5, Photo 1: Existing Rip Rap (Looking Upstream (East toward Nottingham Road))**

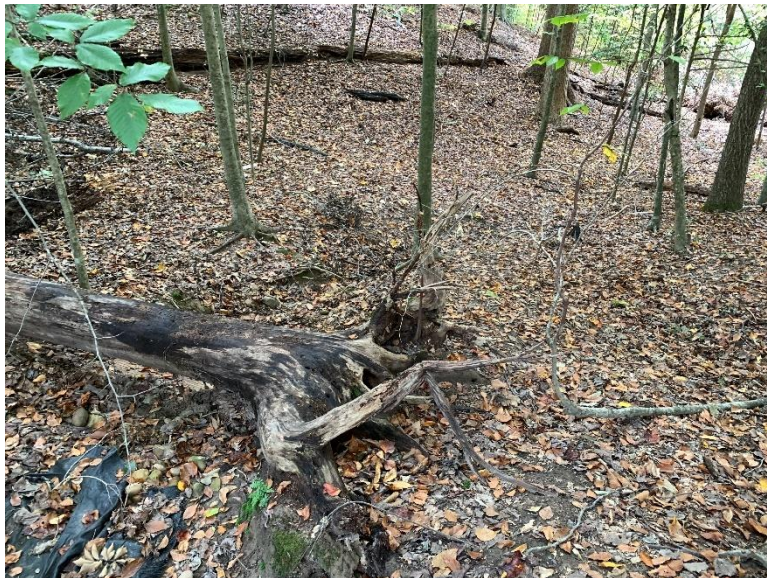
**Site 5, Photo 2: End of Existing Rip Rap (Looking downstream (West))**

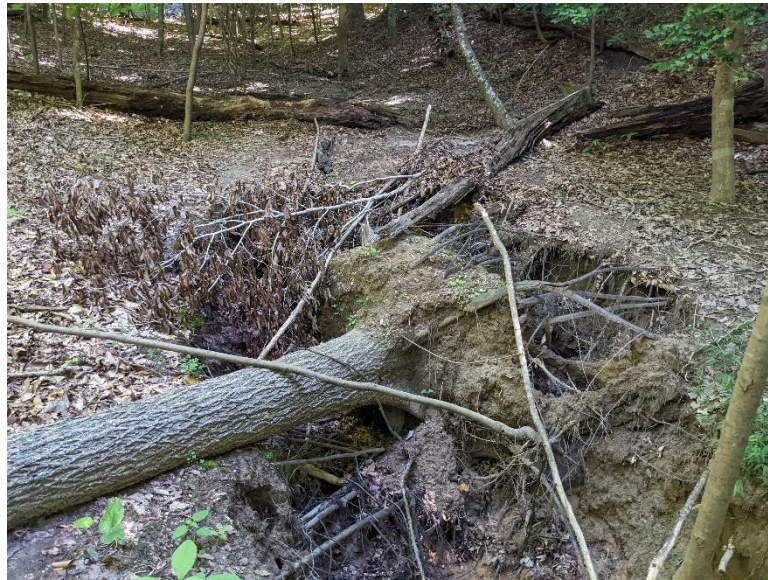
**Site 5, Photo 3: Severe Erosion / Fallen Tree (Looking Upstream (East)) (Aug. 2022)**

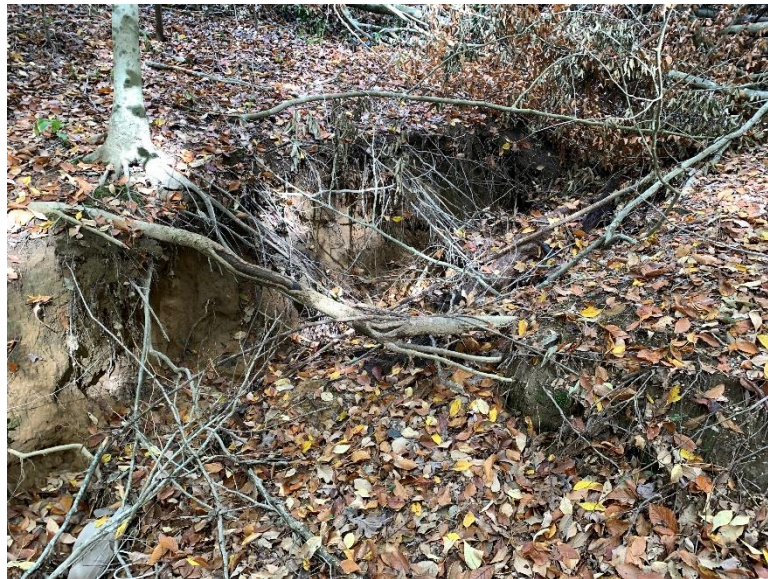
**Site 5, Photo 4: Severe Erosion / Additional Fallen Tree (Looking Upstream (East)) (Nov. 2022)**

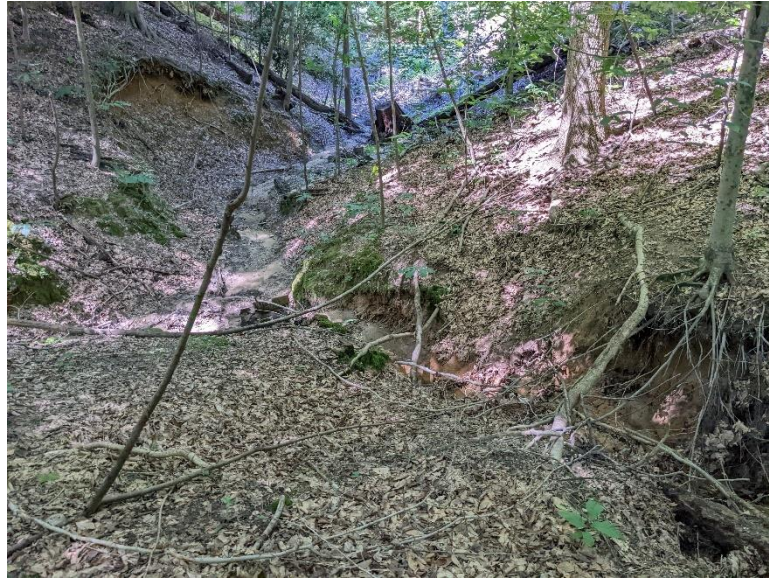
**Site 5, Photo 5: Bank Erosion (Looking Downstream (West))**

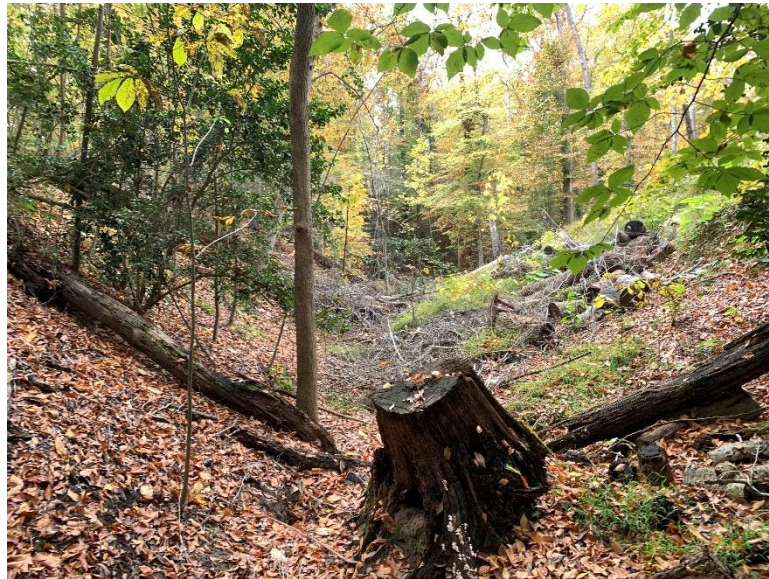
**Site 5, Photo 6: Debris (Looking Downstream (West))**

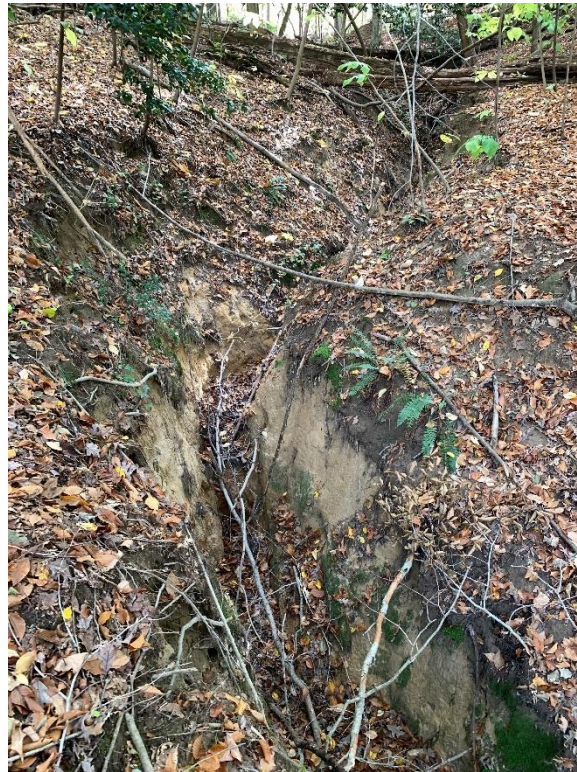
**Site 5, Photo 7: Bottom of Eroded Ditch towards 271 Princess Place (Looking Upstream (Southeast))**

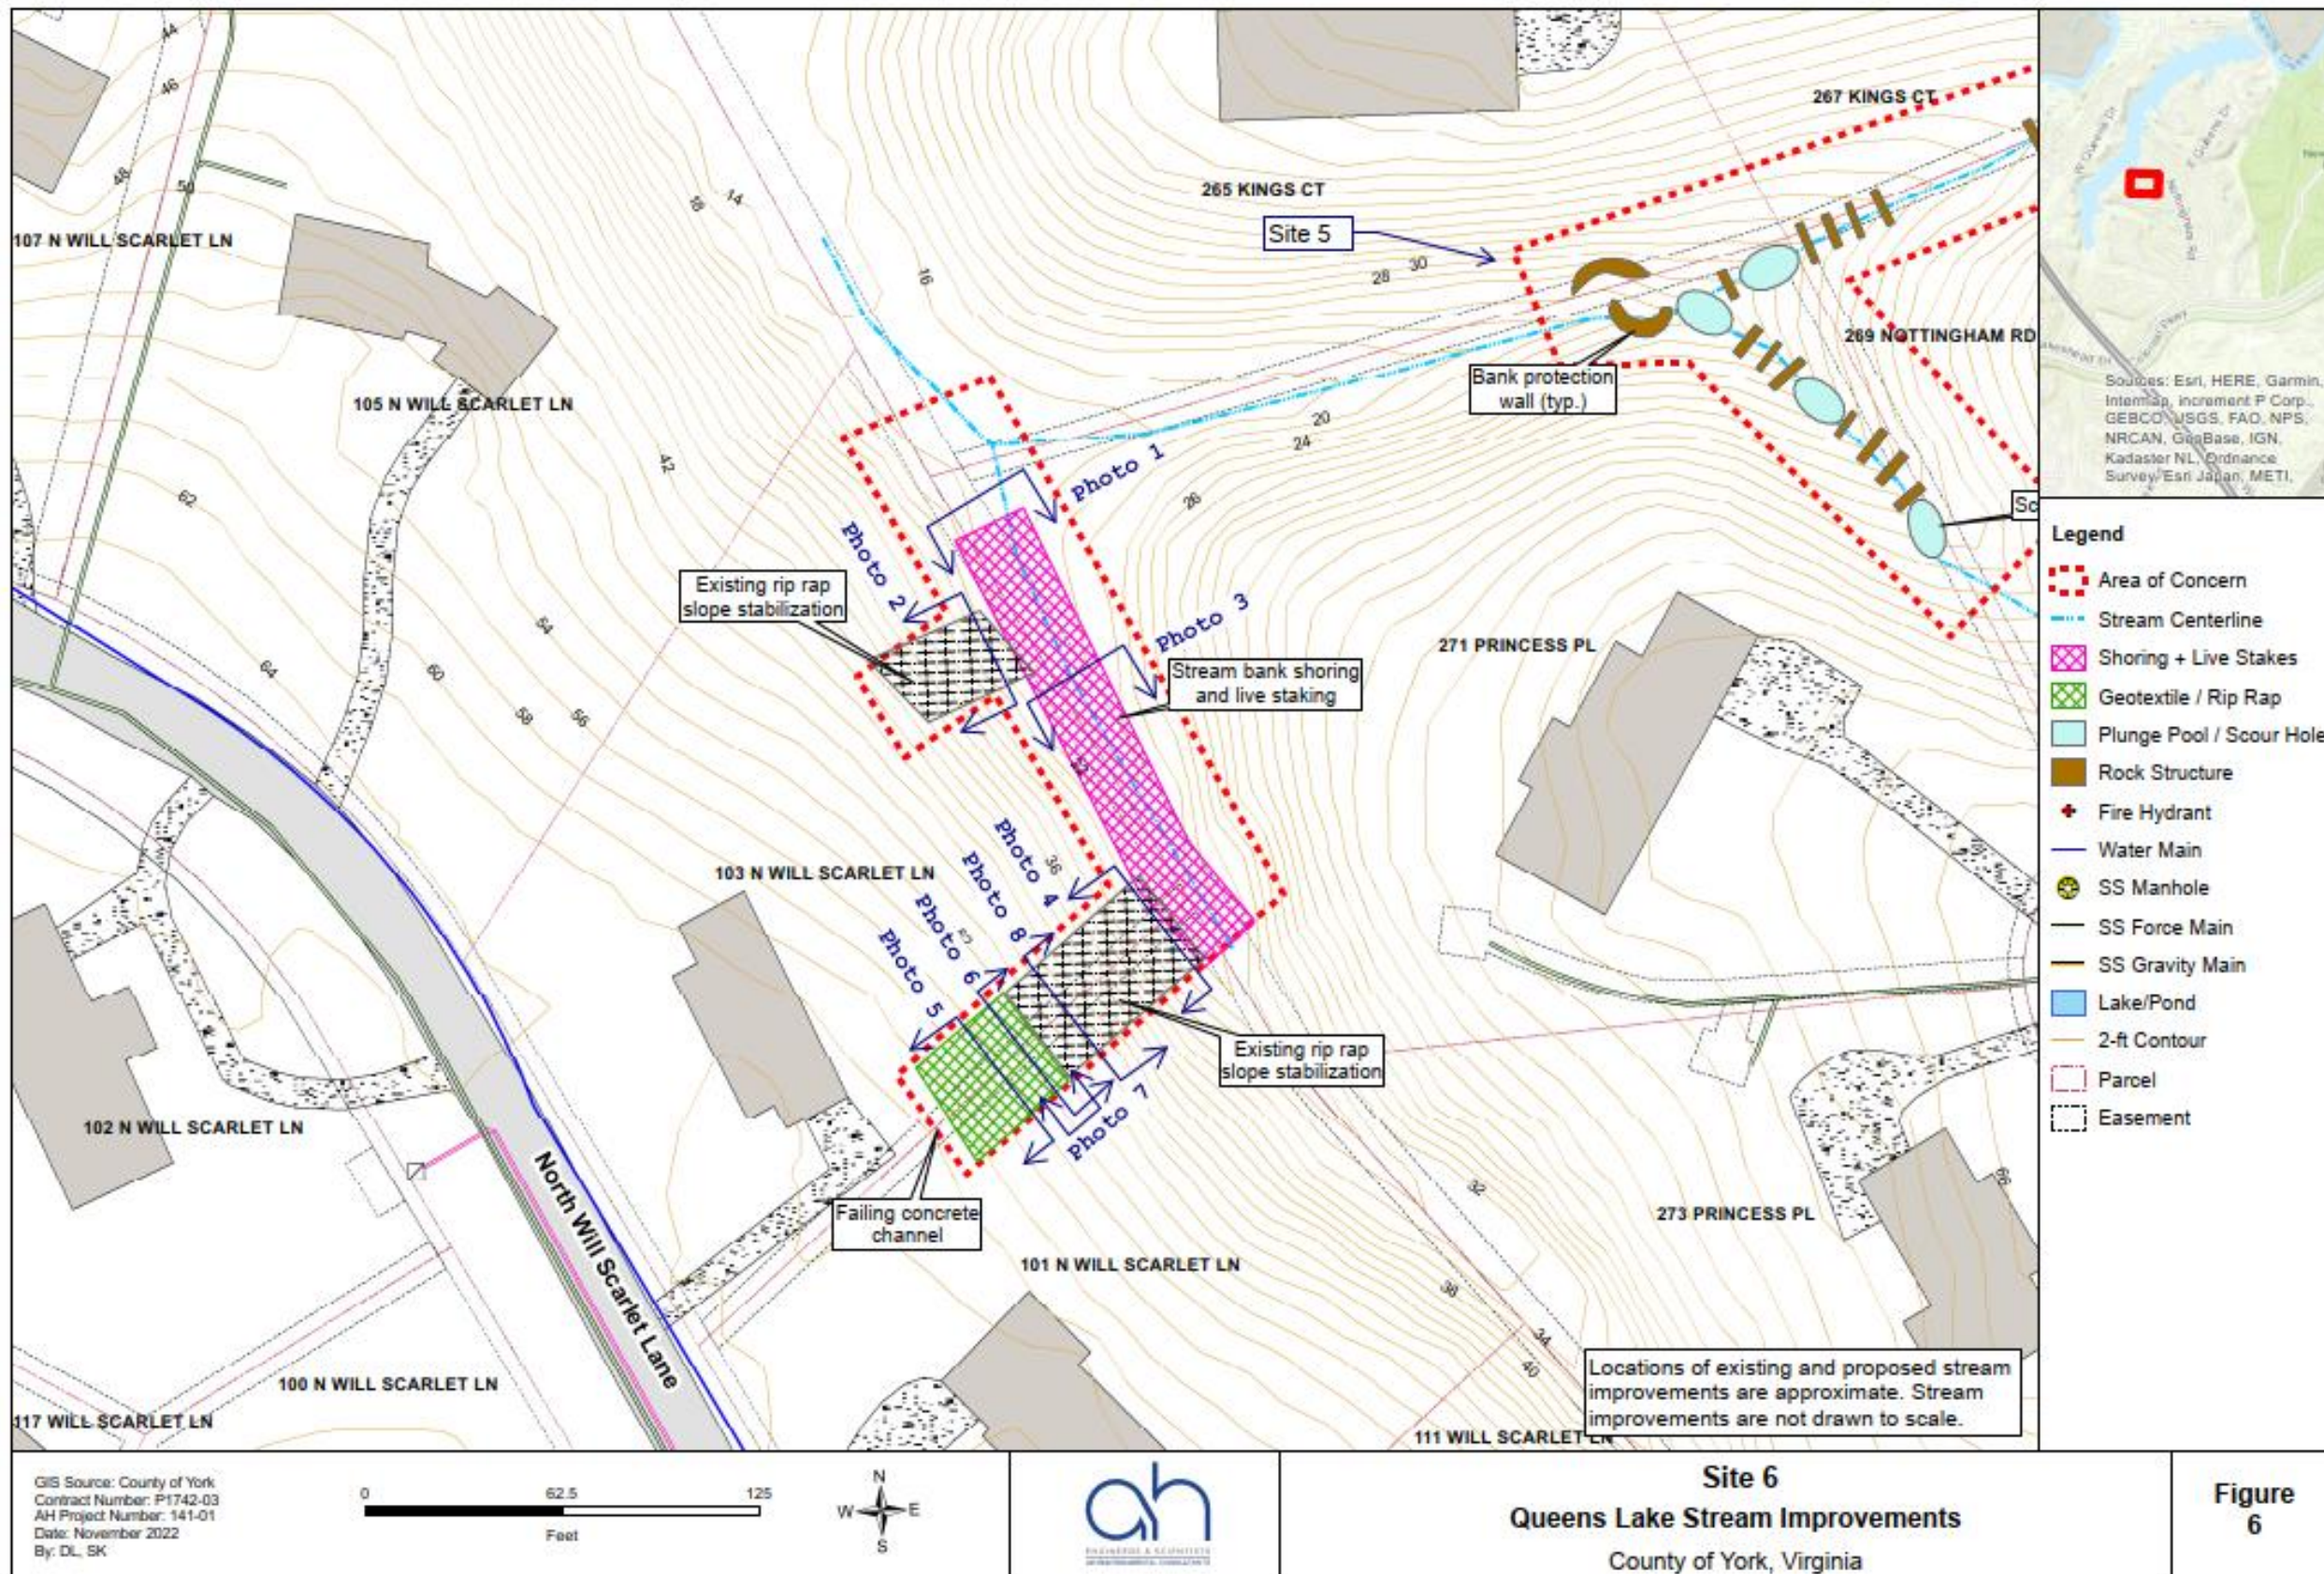
Site 6, located between North Will Scarlet Lane and Princess Place, comprises approximately 200 LF of channel/stream bank erosion downstream of an area where prior slope stabilization efforts (rip rap) have been applied. Upstream of the eroded slope is a failed concrete channel. Concentrated flow from this failed channel runs over the existing rip rap slope stabilization and into the stream in question. **Section 3.5.1** provides Site 6 photographs capturing these conditions.

**Figure 6** identifies the primary areas of concern, location of photographs, and preliminary recommended corrective actions. Site 6 requires approximately 200 LF of restoration activities, including the following:

- Up to 200 LF of bank shoring and live stakes
- Approximately 2,000 SF of rip rap slope stabilization

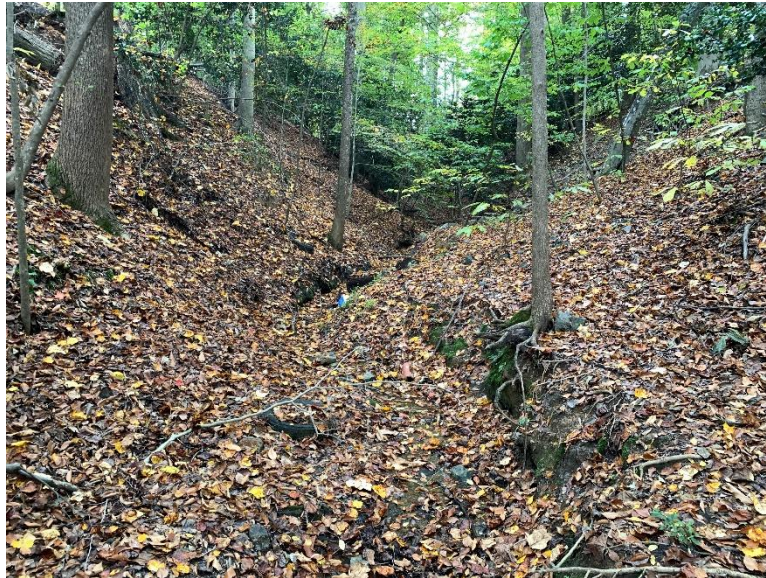
**Site 6, Photo 1: View of Stream (Looking Upstream (Southeast))**

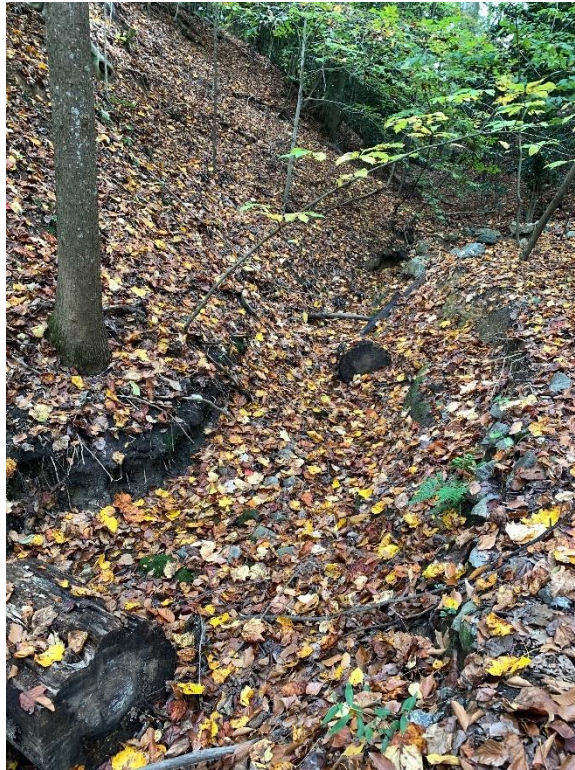
**Site 6, Photo 3: View of Stream (Looking Upstream (Southeast))**

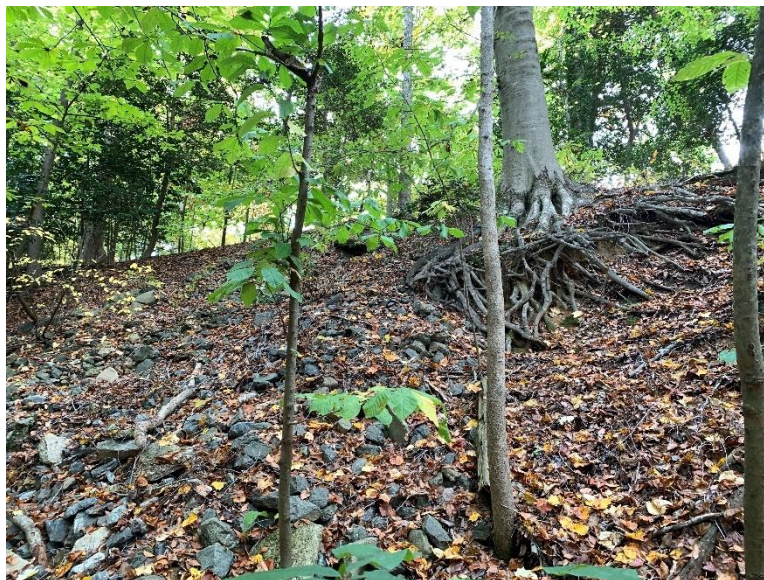
**Site 6, Photo 4: Existing Rip Rap Slope Stabilization (Bottom of Slope, Looking Southwest)**

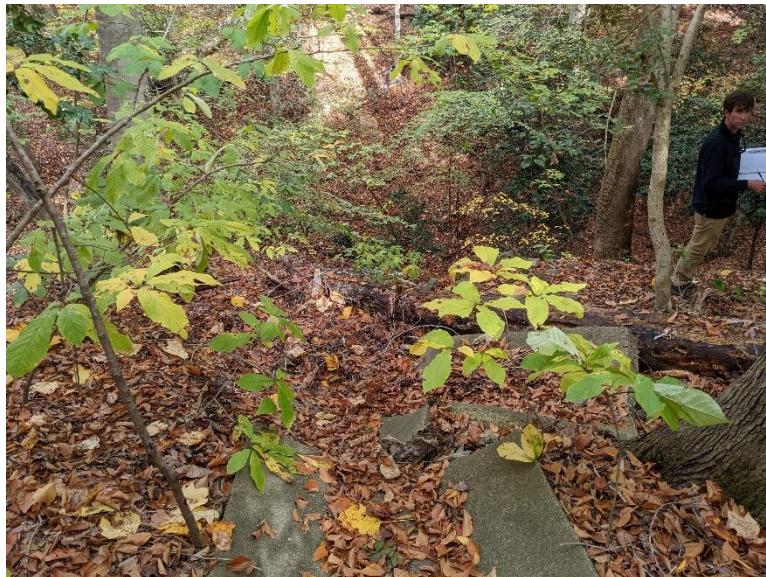
**Site 6, Photo 6: End of Existing Damaged Concrete Channel at 103 North Will Scarlet Lane (Looking Downstream (Northeast))**

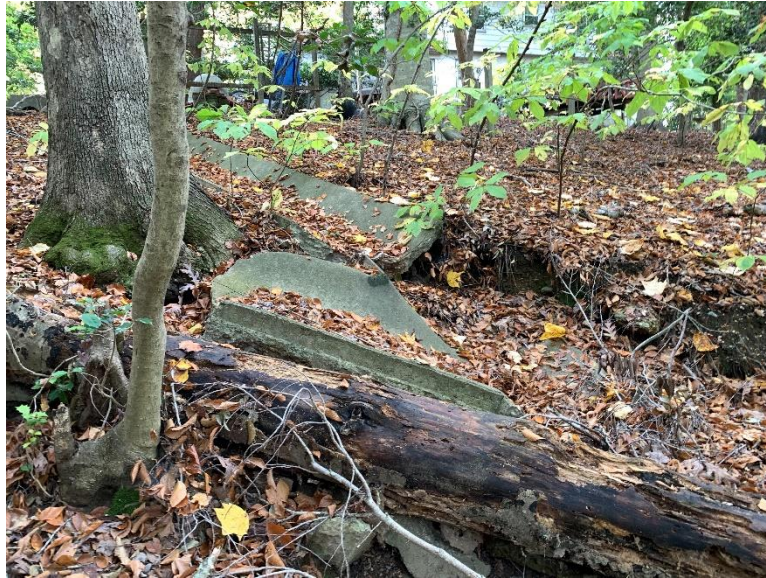
**Site 6, Photo 7: End of Existing Damaged Concrete Channel at 103 North Will Scarlet Lane (Side View, Looking Northwest)**

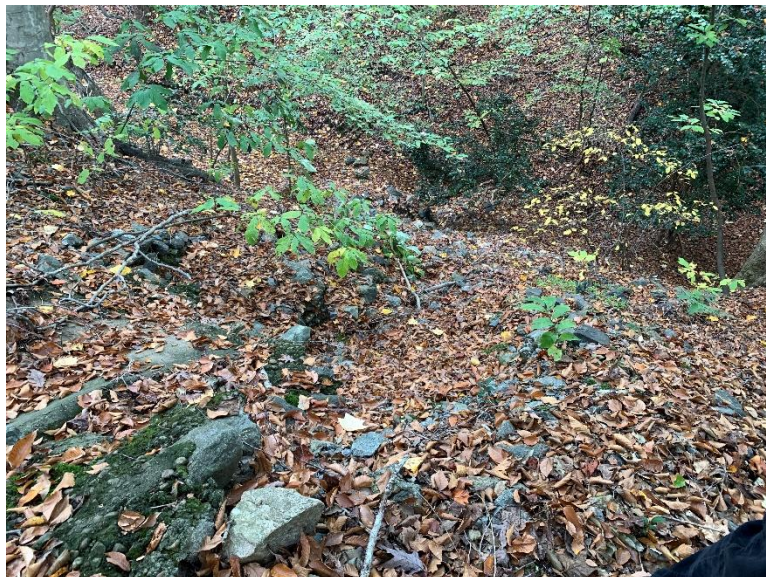
**Site 6, Photo 8: End of Existing Concrete Channel / Existing Rip Rap Slope Stabilization (Top of Slope, Looking Northeast)**

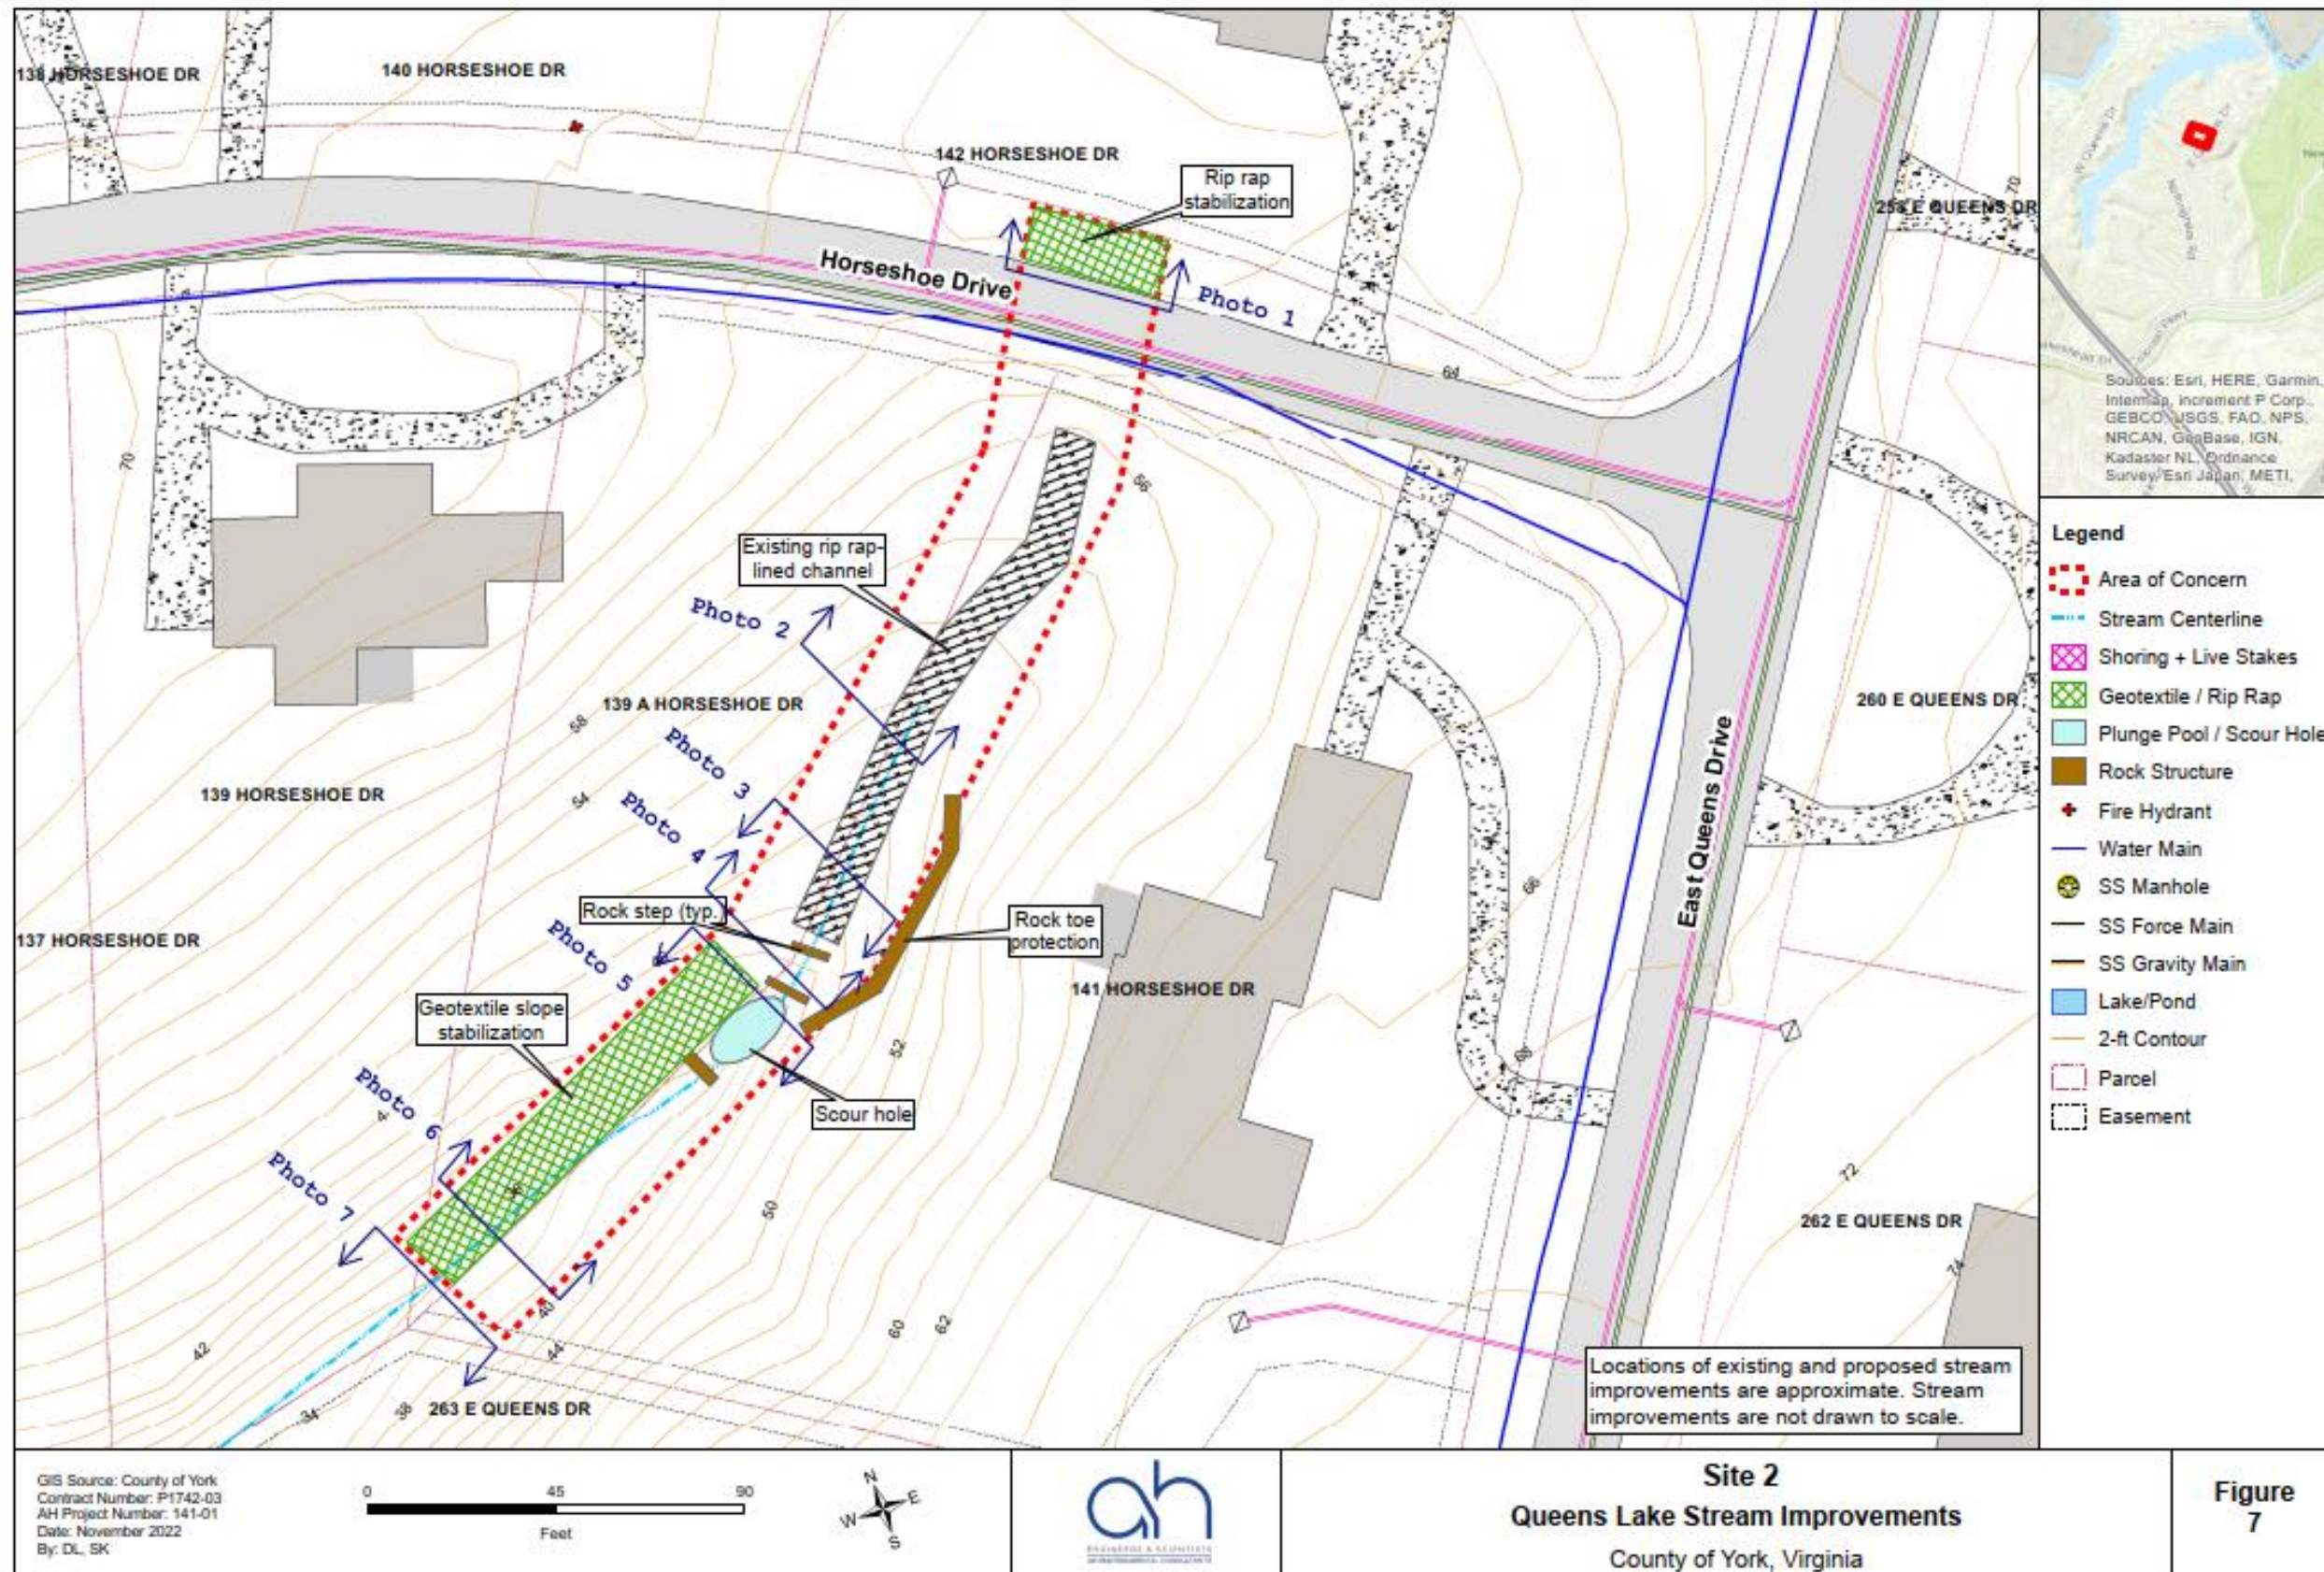
Site 2, located near the intersection of East Queens Drive and Horseshoe Drive, comprises approximately 200 LF of channel/ stream bank erosion downstream of a rip rap channel. In addition to the existing rip rap channel stabilization, an adjacent homeowner has attempted to stabilize the slope behind their home (139 Horseshoe Drive) with logs and other organic materials. Gully erosion was also observed on the north side of Horseshoe Drive, upstream of the inlet to the culvert under the road. **Section 3.6.1** provides Site 2 photographs capturing these conditions.

**Figure 7** identifies the primary areas of concern, location of photographs, and preliminary recommended corrective actions. Site 2 requires approximately 200 LF of restoration activities, including the following:

- 1 plunge pool / scour hole
- Rock toe protection
- 2-4 rock steps (and/or cross vanes)
- Approximately 2,000 SF of geotextile slope stabilization
- Approximately 400 SF of rip rap stabilization
- Up to 4 large (>12" diameter) trees for potential removal

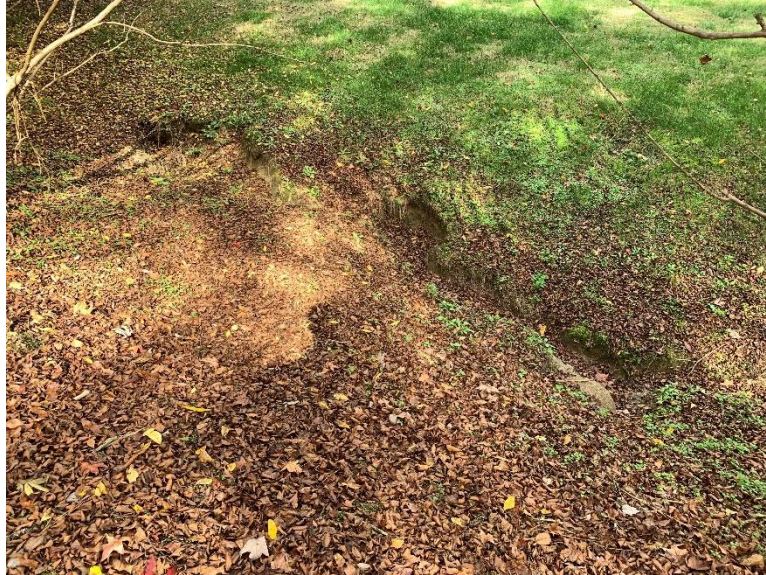
**Site 2, Photo 1: Erosion on the Northeast side of Horseshoe Drive**

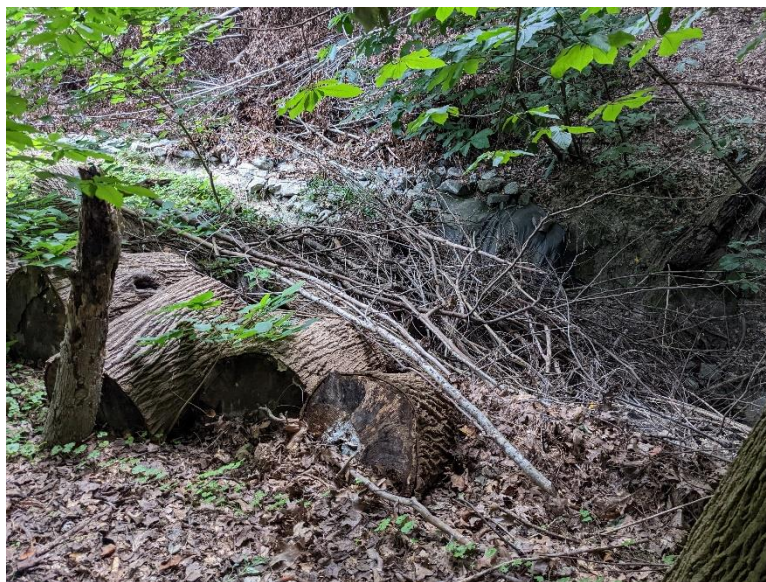
**Site 2, Photo 4: Erosion at End of Existing Rip Rap (Looking Upstream (Northeast))**

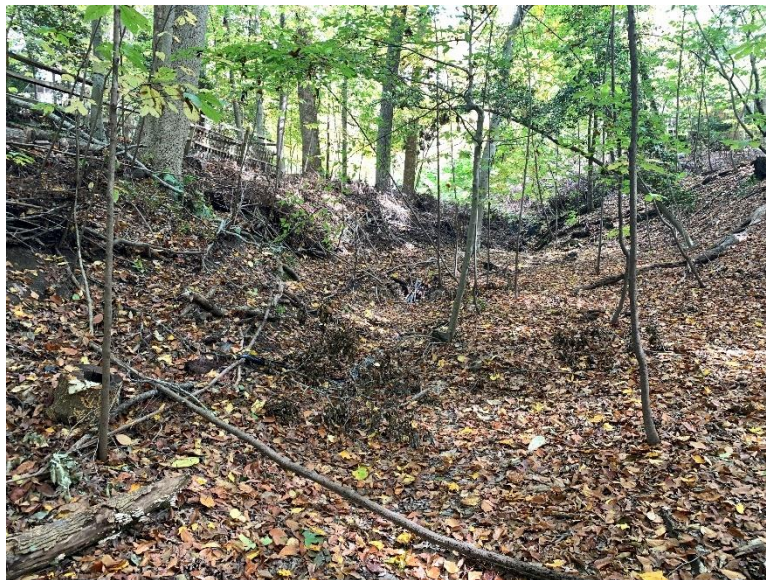
**Site 2, Photo 6: View of Channel (Looking Upstream (Northeast))**
