**TO:** Joe Brogan, Chief of Stormwater Programs  
York County, Virginia  
Department of Public Works (DPW)

**FROM:** AH Environmental Consultants, Inc. (AH)

**SUBJECT:** Preliminary Assessment of Queens Lake Stream Improvements

**DATE:** 23 November 2022

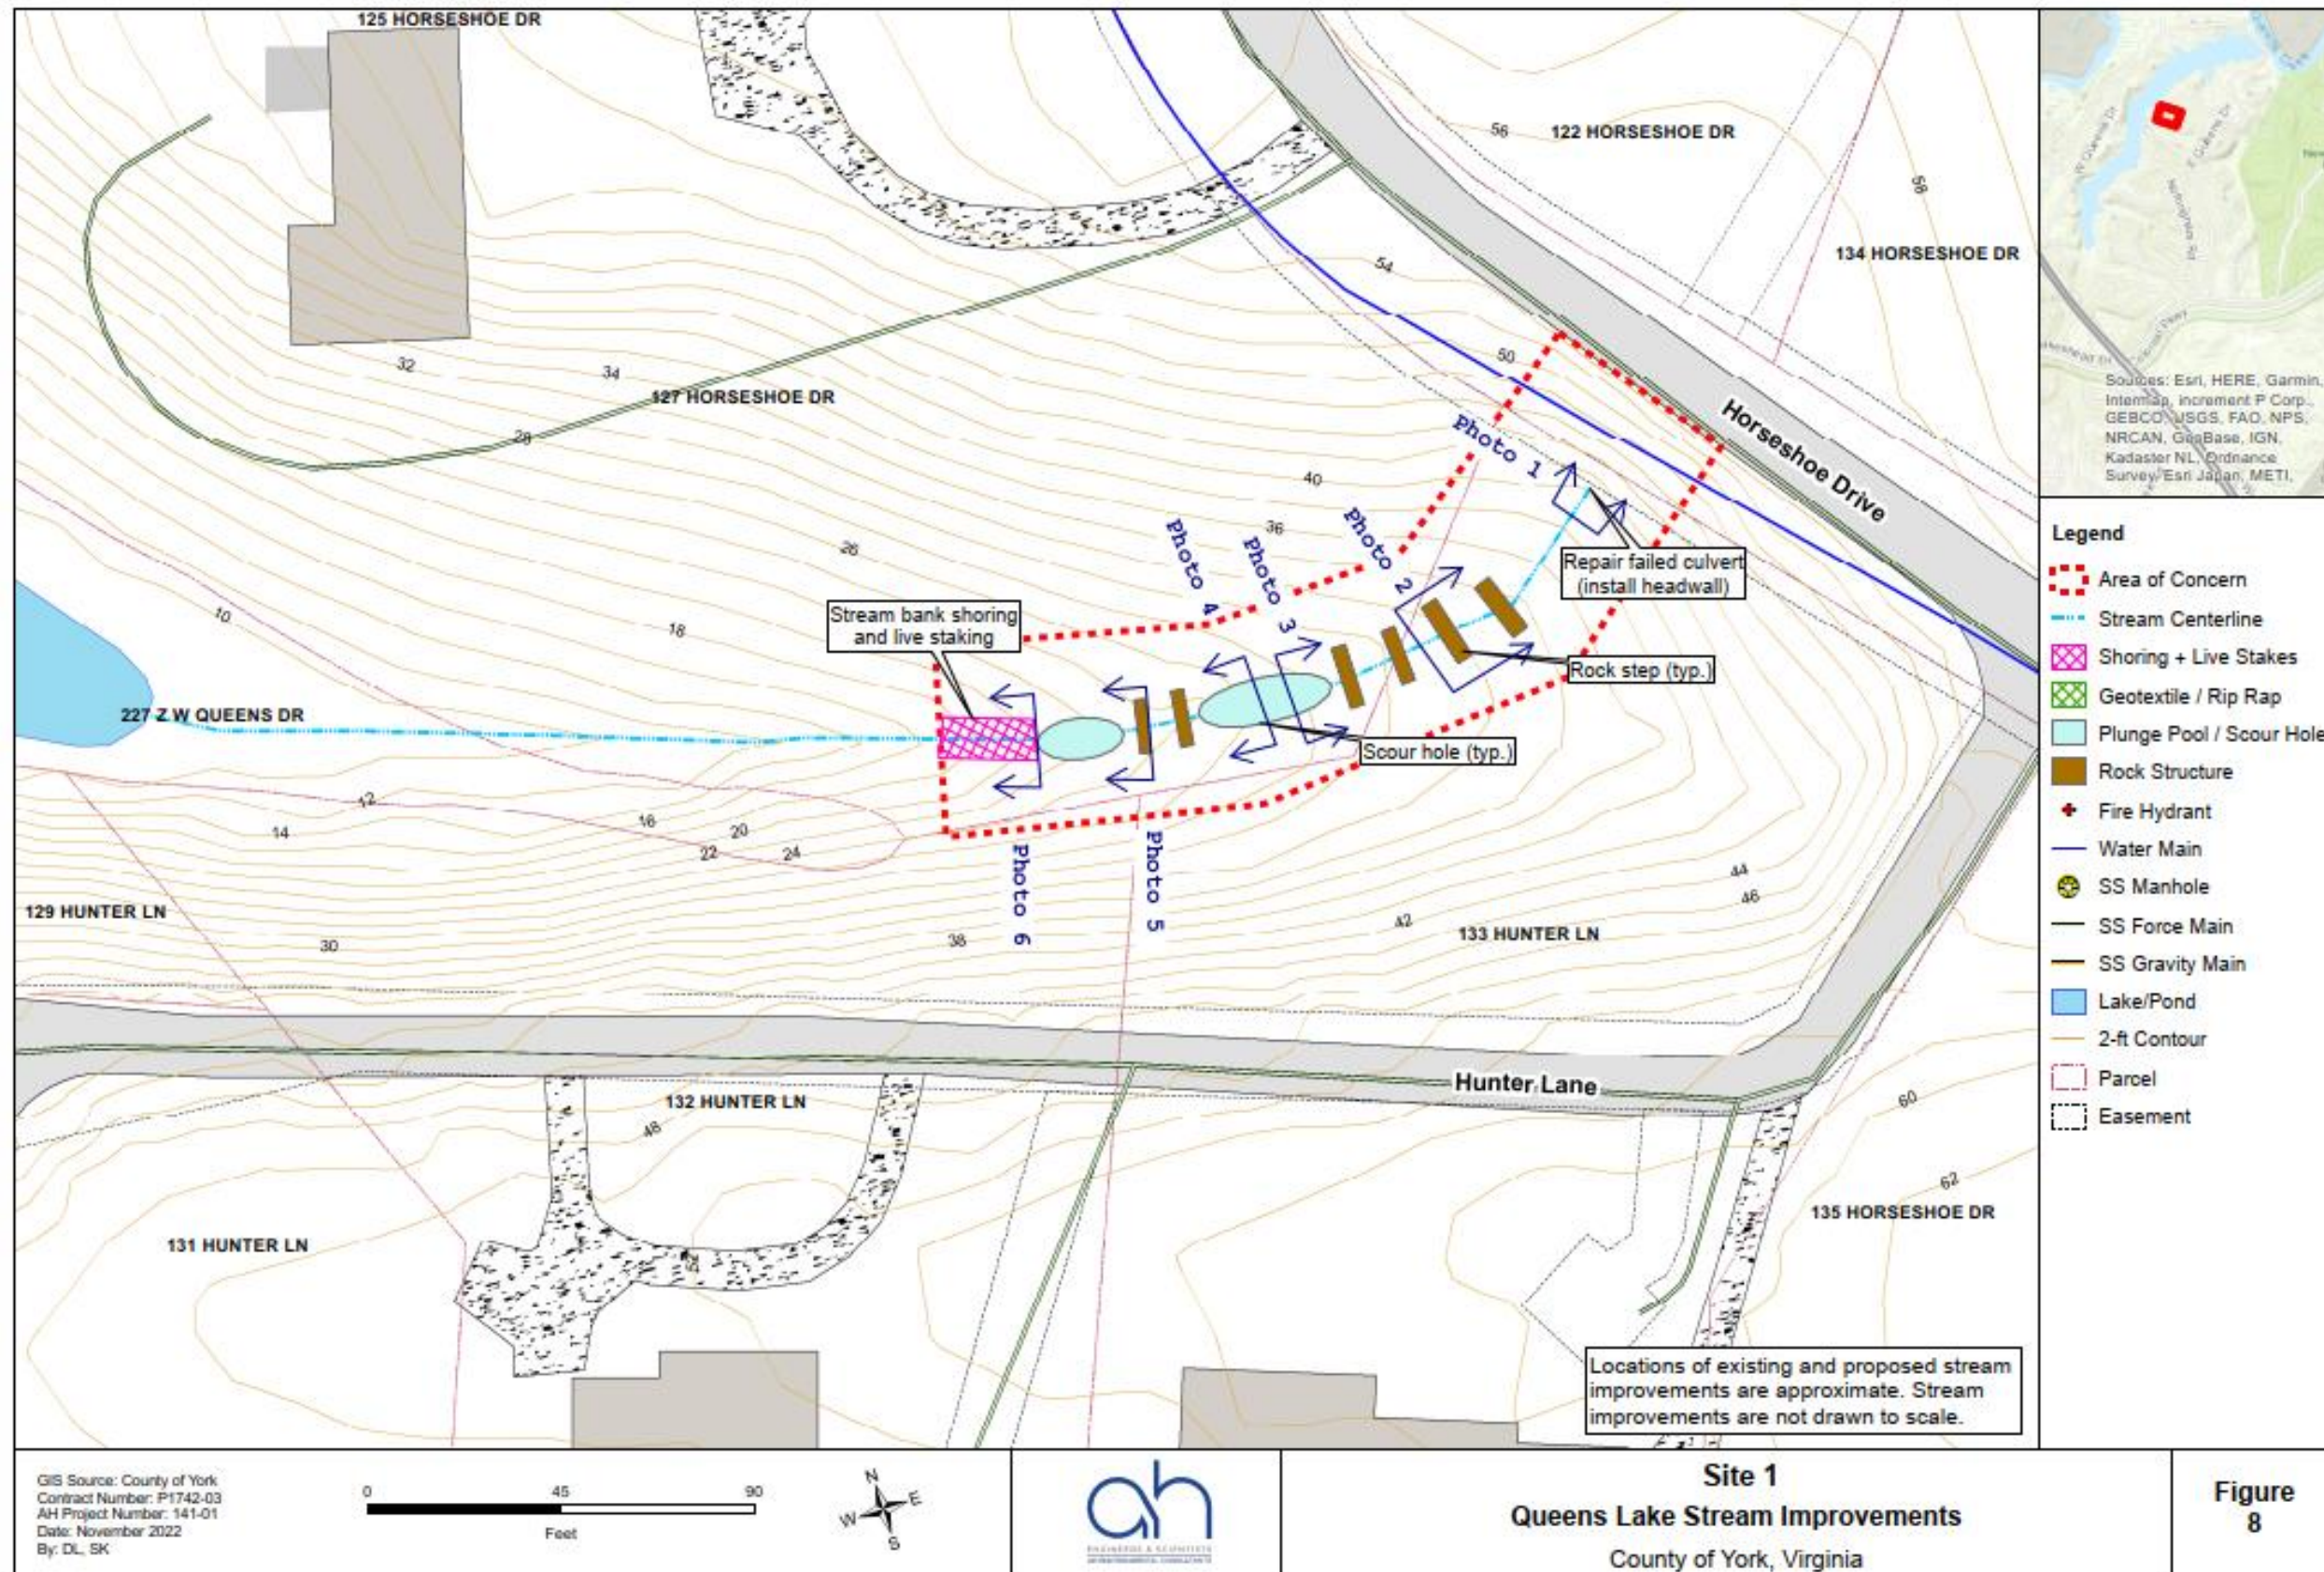
Site 1, located west of Horseshoe Drive and north of Hunter Lane, comprises a failed culvert at the upstream end of the reach, followed by approximately 150-200 LF of gully erosion and stream bank incision. **Section 3.7.1** provides Site 1 photographs capturing these conditions.

**Figure 8** identifies the primary areas of concern, location of photographs, and preliminary recommended corrective actions. Site 1 requires approximately 150-200 LF of restoration activities, including the following:

- 2-3 plunge pools / scour holes
- 5-8 rock steps (and/or cross vanes)
- Up to 50 LF of bank shoring and live stakes
- Up to 10 large (>12" diameter) trees for potential removal

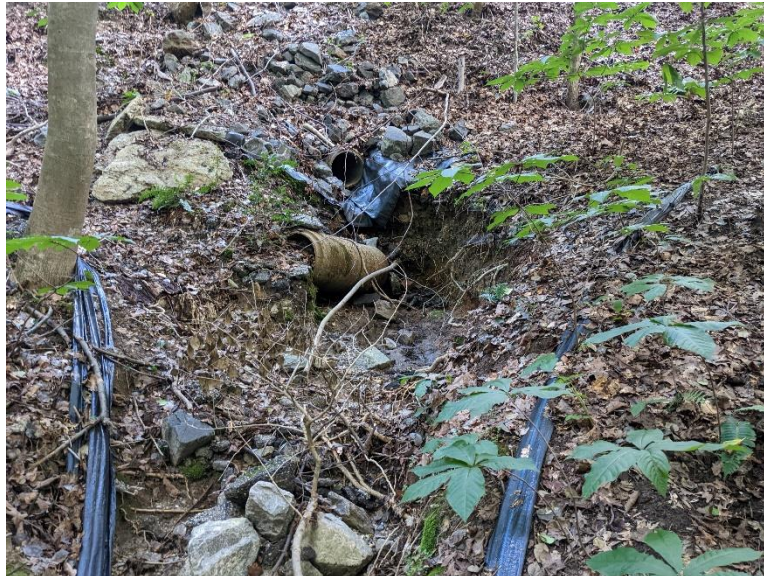
**Site 1, Photo 1: Failed culvert near Horseshoe Drive (Looking Upstream (Northeast))**

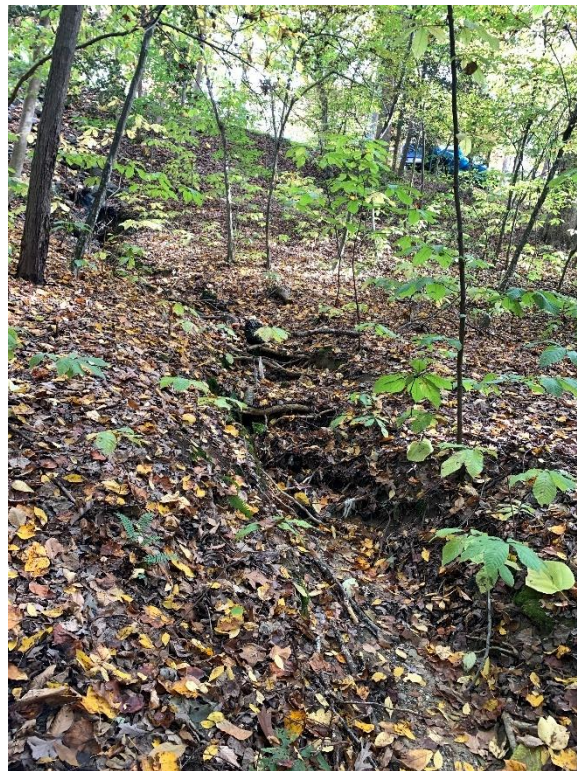
**Site 1, Photo 2: Area downstream of failed culvert (Looking Upstream (Northeast))**

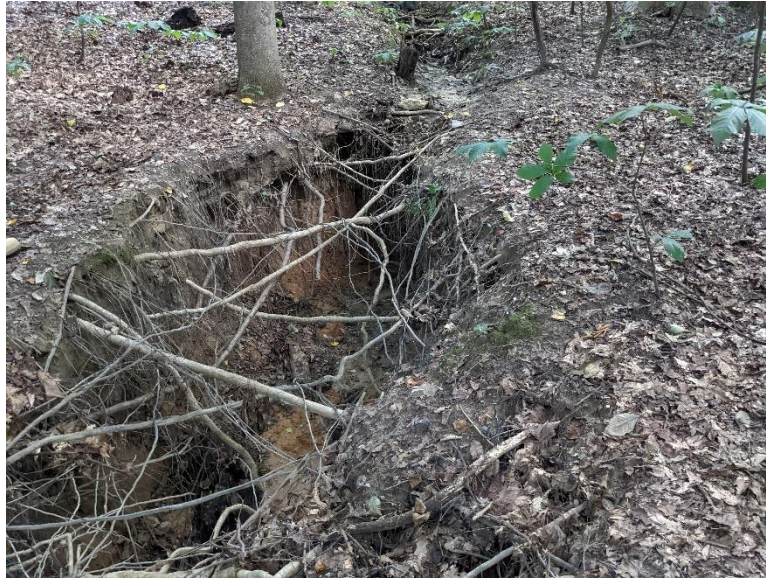
**Site 1, Photo 3: Start of large erosion downstream of failed culvert (Looking Upstream (East))**

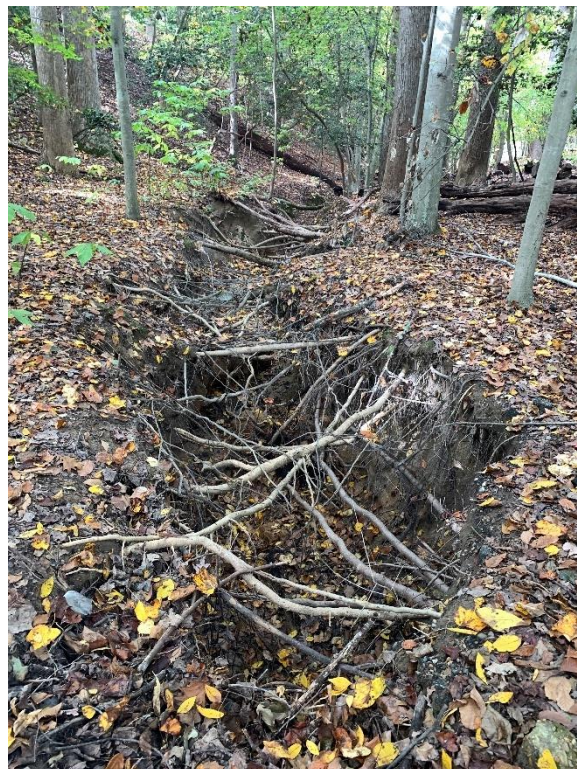
**Site 1, Photo 4: Eroded ditch downstream of failed culvert (Looking Downstream (West))**

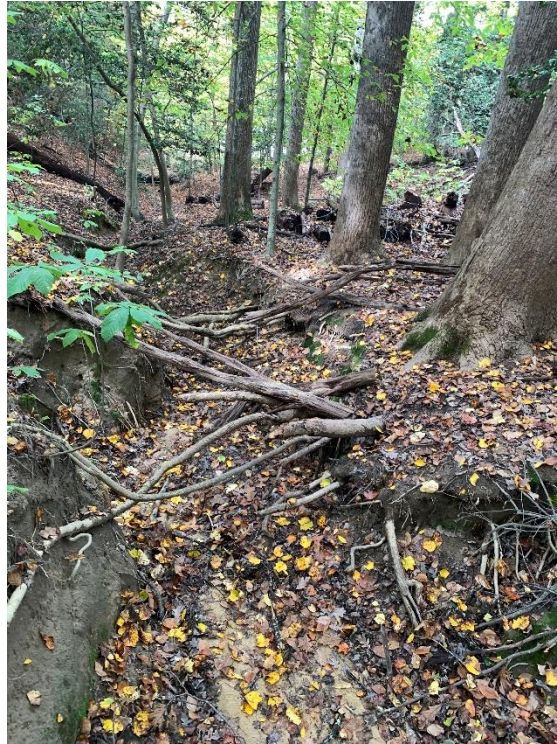
**Site 1, Photo 5: Continuation of eroded ditch (Looking Downstream (West))**

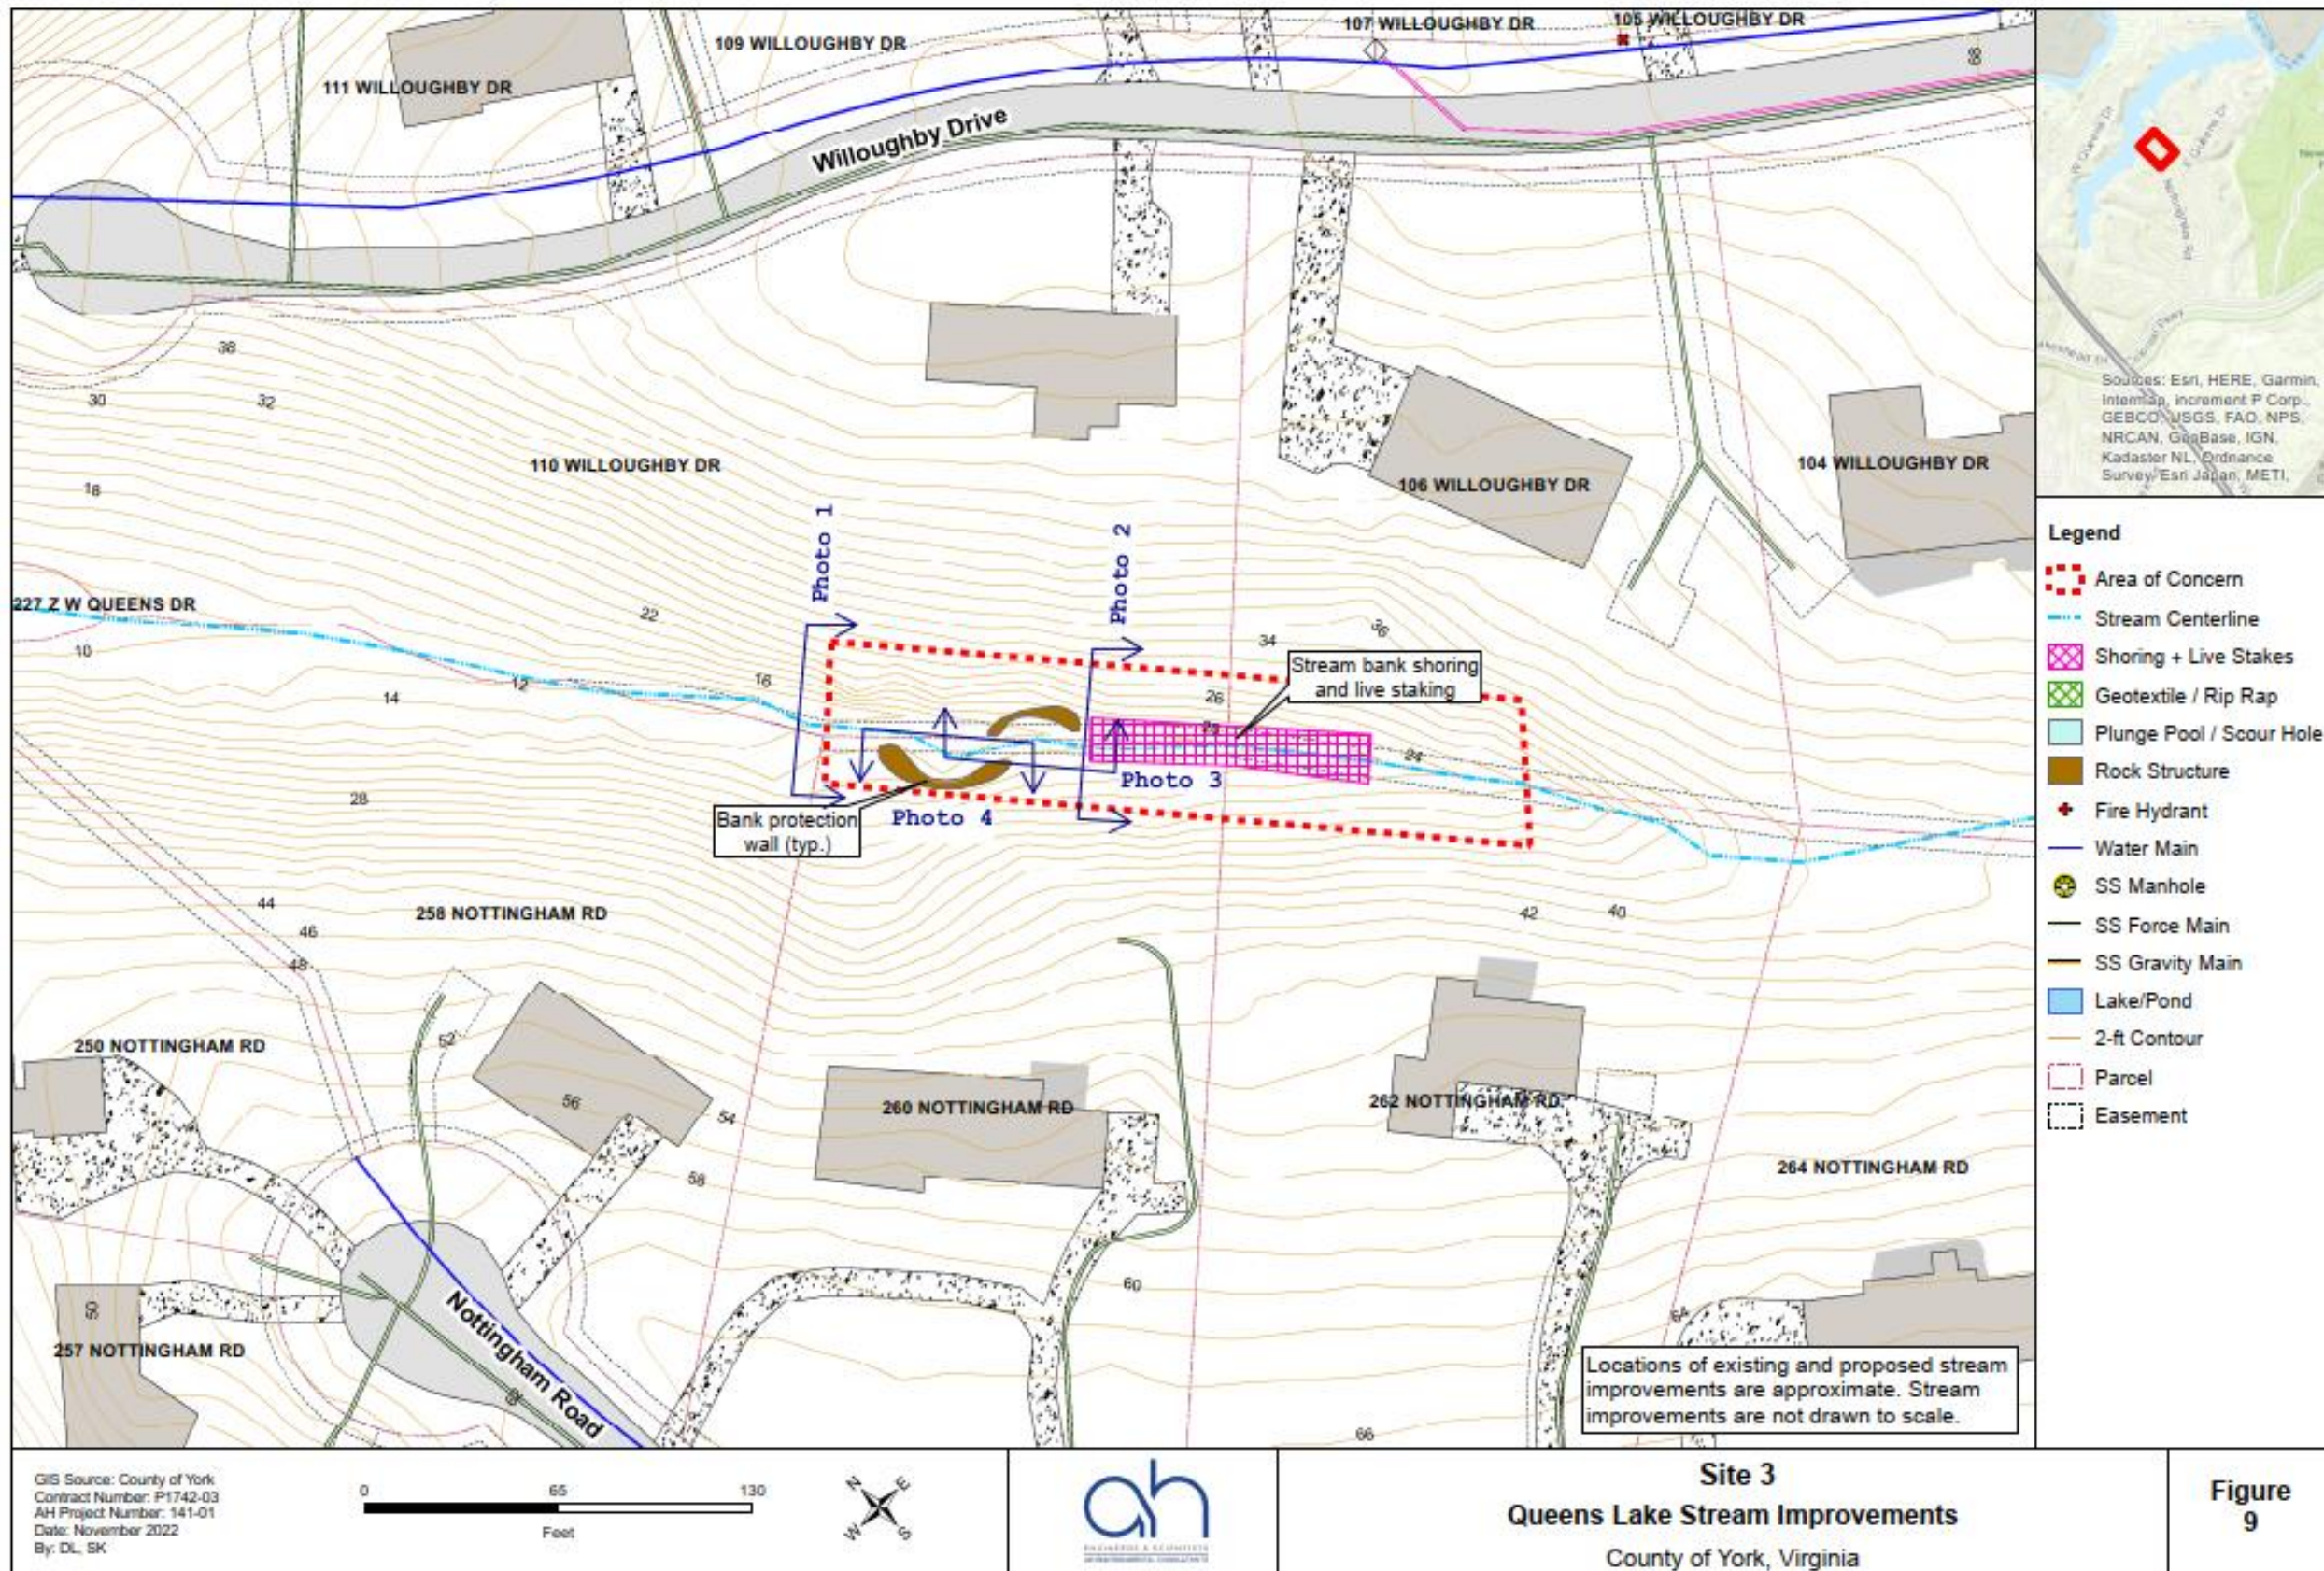
Site 3, located between Willoughby Drive and Nottingham Road, comprises approximately 100 LF of moderate stream bank incision followed by two areas of severe bank slope erosion. **Section 3.8.1** presents Site 3 photographs capturing these conditions.

**Figure 9** identifies the primary areas of concern, location of photographs, and preliminary recommended corrective actions. Site 3 requires approximately 200 LF of restoration activities, including the following:

- 2 bank protection walls (stacked stone or other material)
- Up to 150 LF of bank shoring and live stakes
- Approximately 4 large (>12” diameter) trees for potential removal

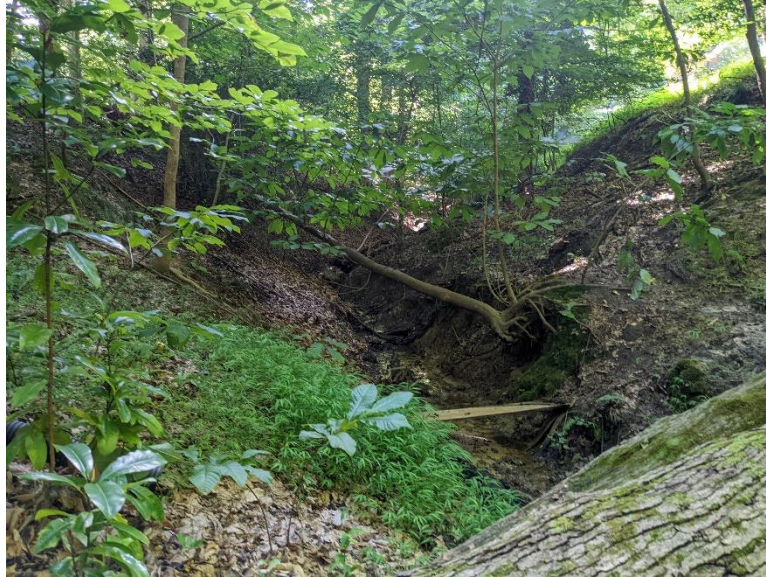
**Site 3, Photo 1: View of Stream (Looking Upstream (Southeast))**

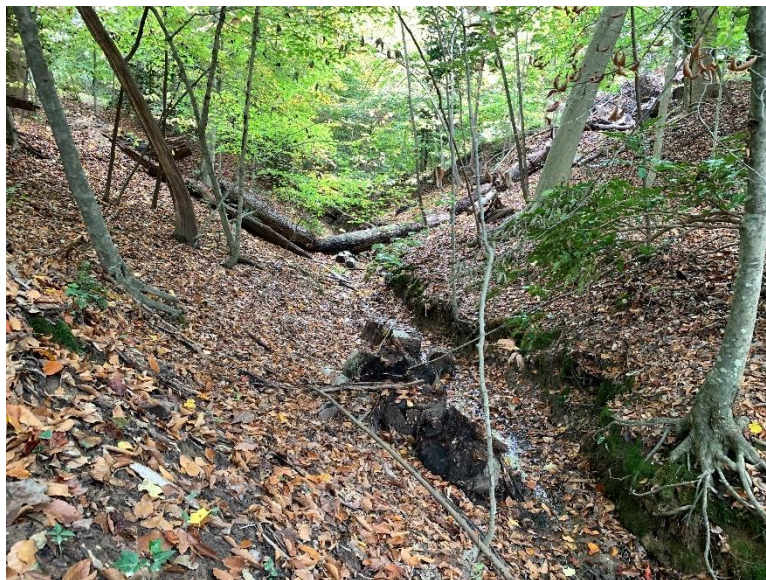
**Site 3, Photo 2: View of Stream (Looking Upstream (Southeast))**

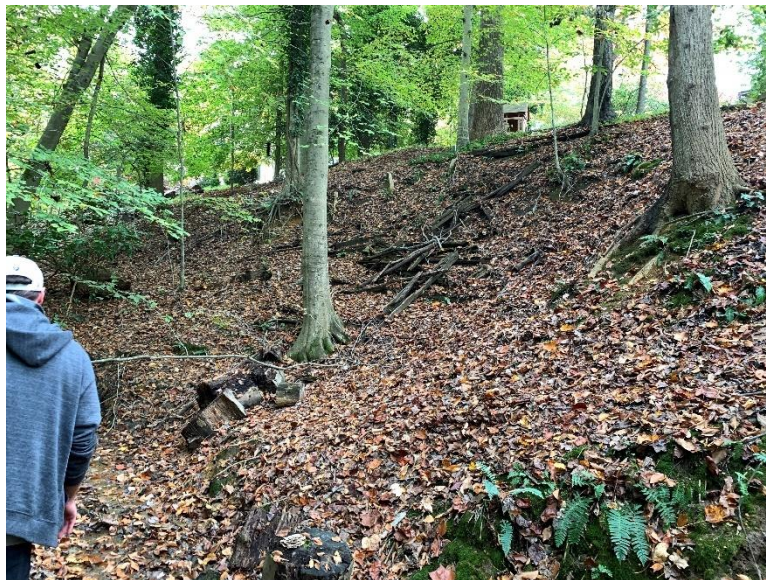
**Site 3, Photo 4: Slope Erosion behind 260 Nottingham Road (Looking Southwest)**

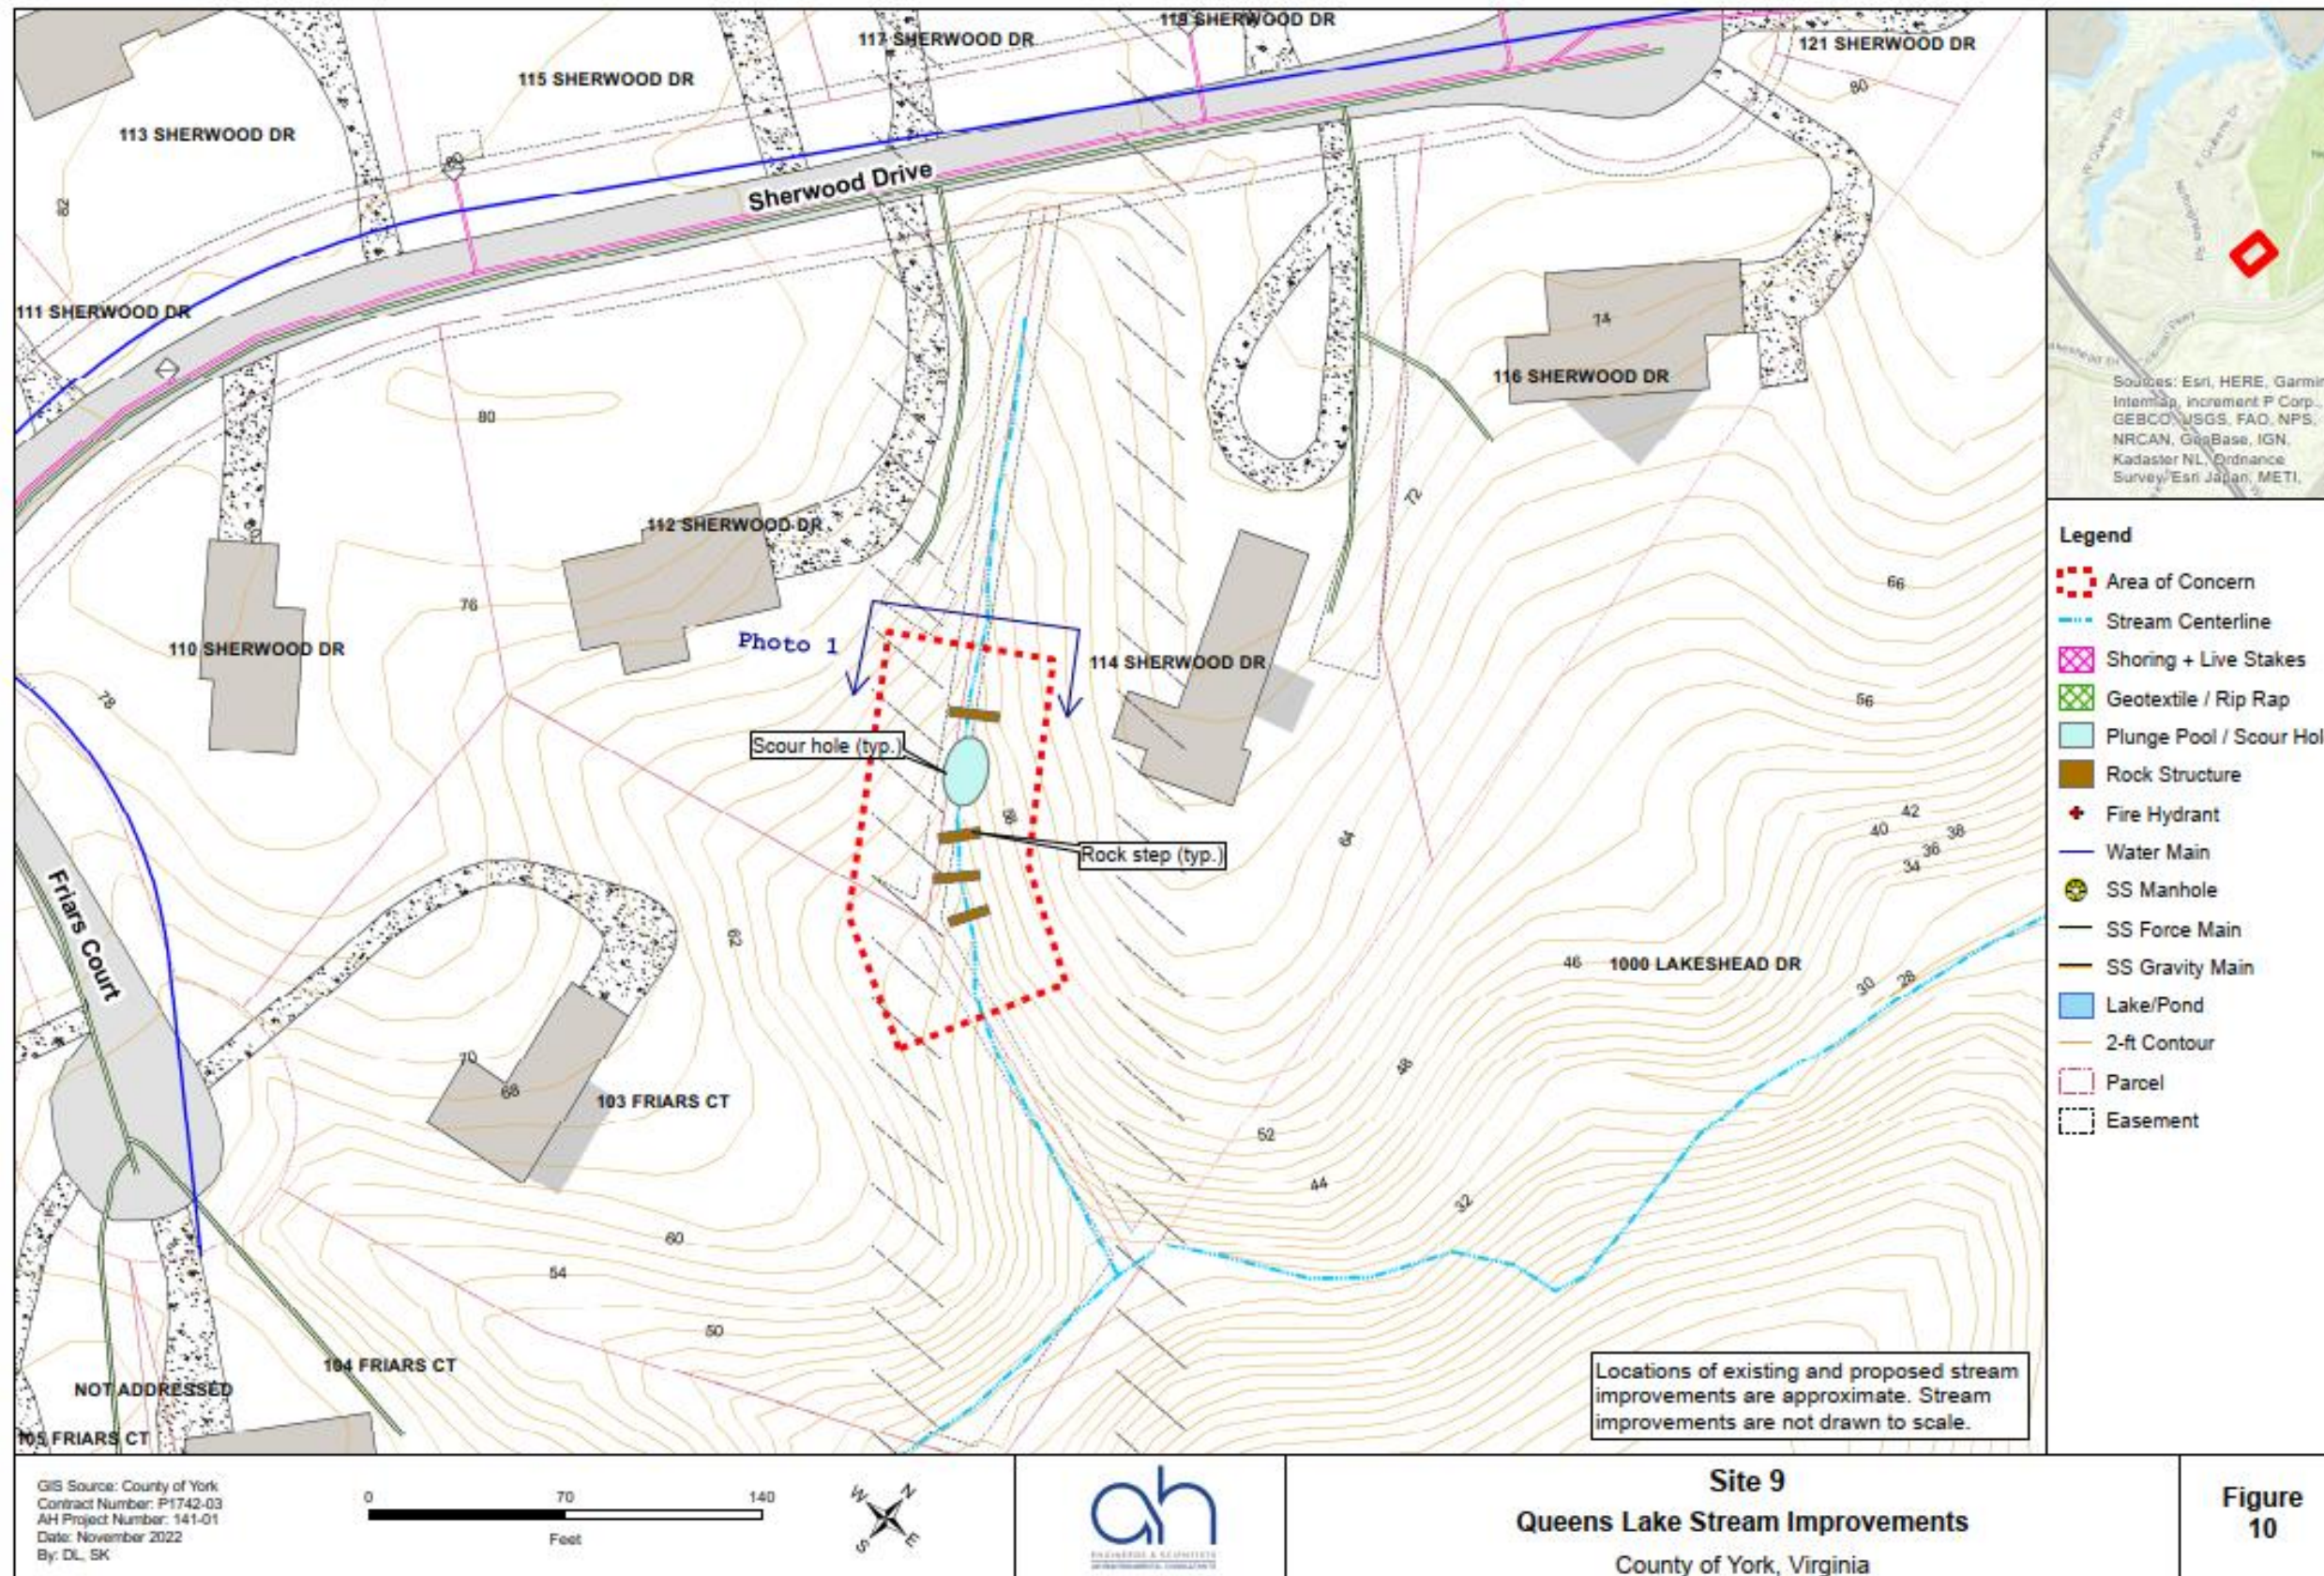
Site 9, located on the east side of Sherwood Drive between addresses 112 and 114, comprises approximately 100 LF of stream bank incision and gully erosion. **Section 3.9.1** includes Site 9 photographs capturing these conditions.

**Figure 10** identifies the primary areas of concern, location of photographs, and preliminary recommended corrective actions. Site 9 requires approximately 100 LF of restoration activities, including the following:

- 1-2 plunge pools / scour holes
- 4-6 rock steps (and/or cross vanes)
- Up to 50 LF of bank shoring and live stakes
- Up to 4 large (>12" diameter) trees for potential removal

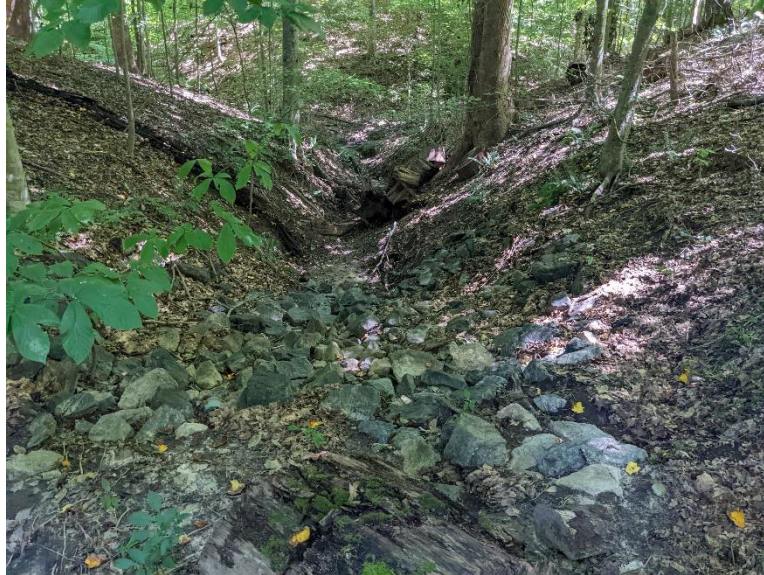
**Site 9, Photo 1: View of Channel (Looking Downstream (Southeast))**

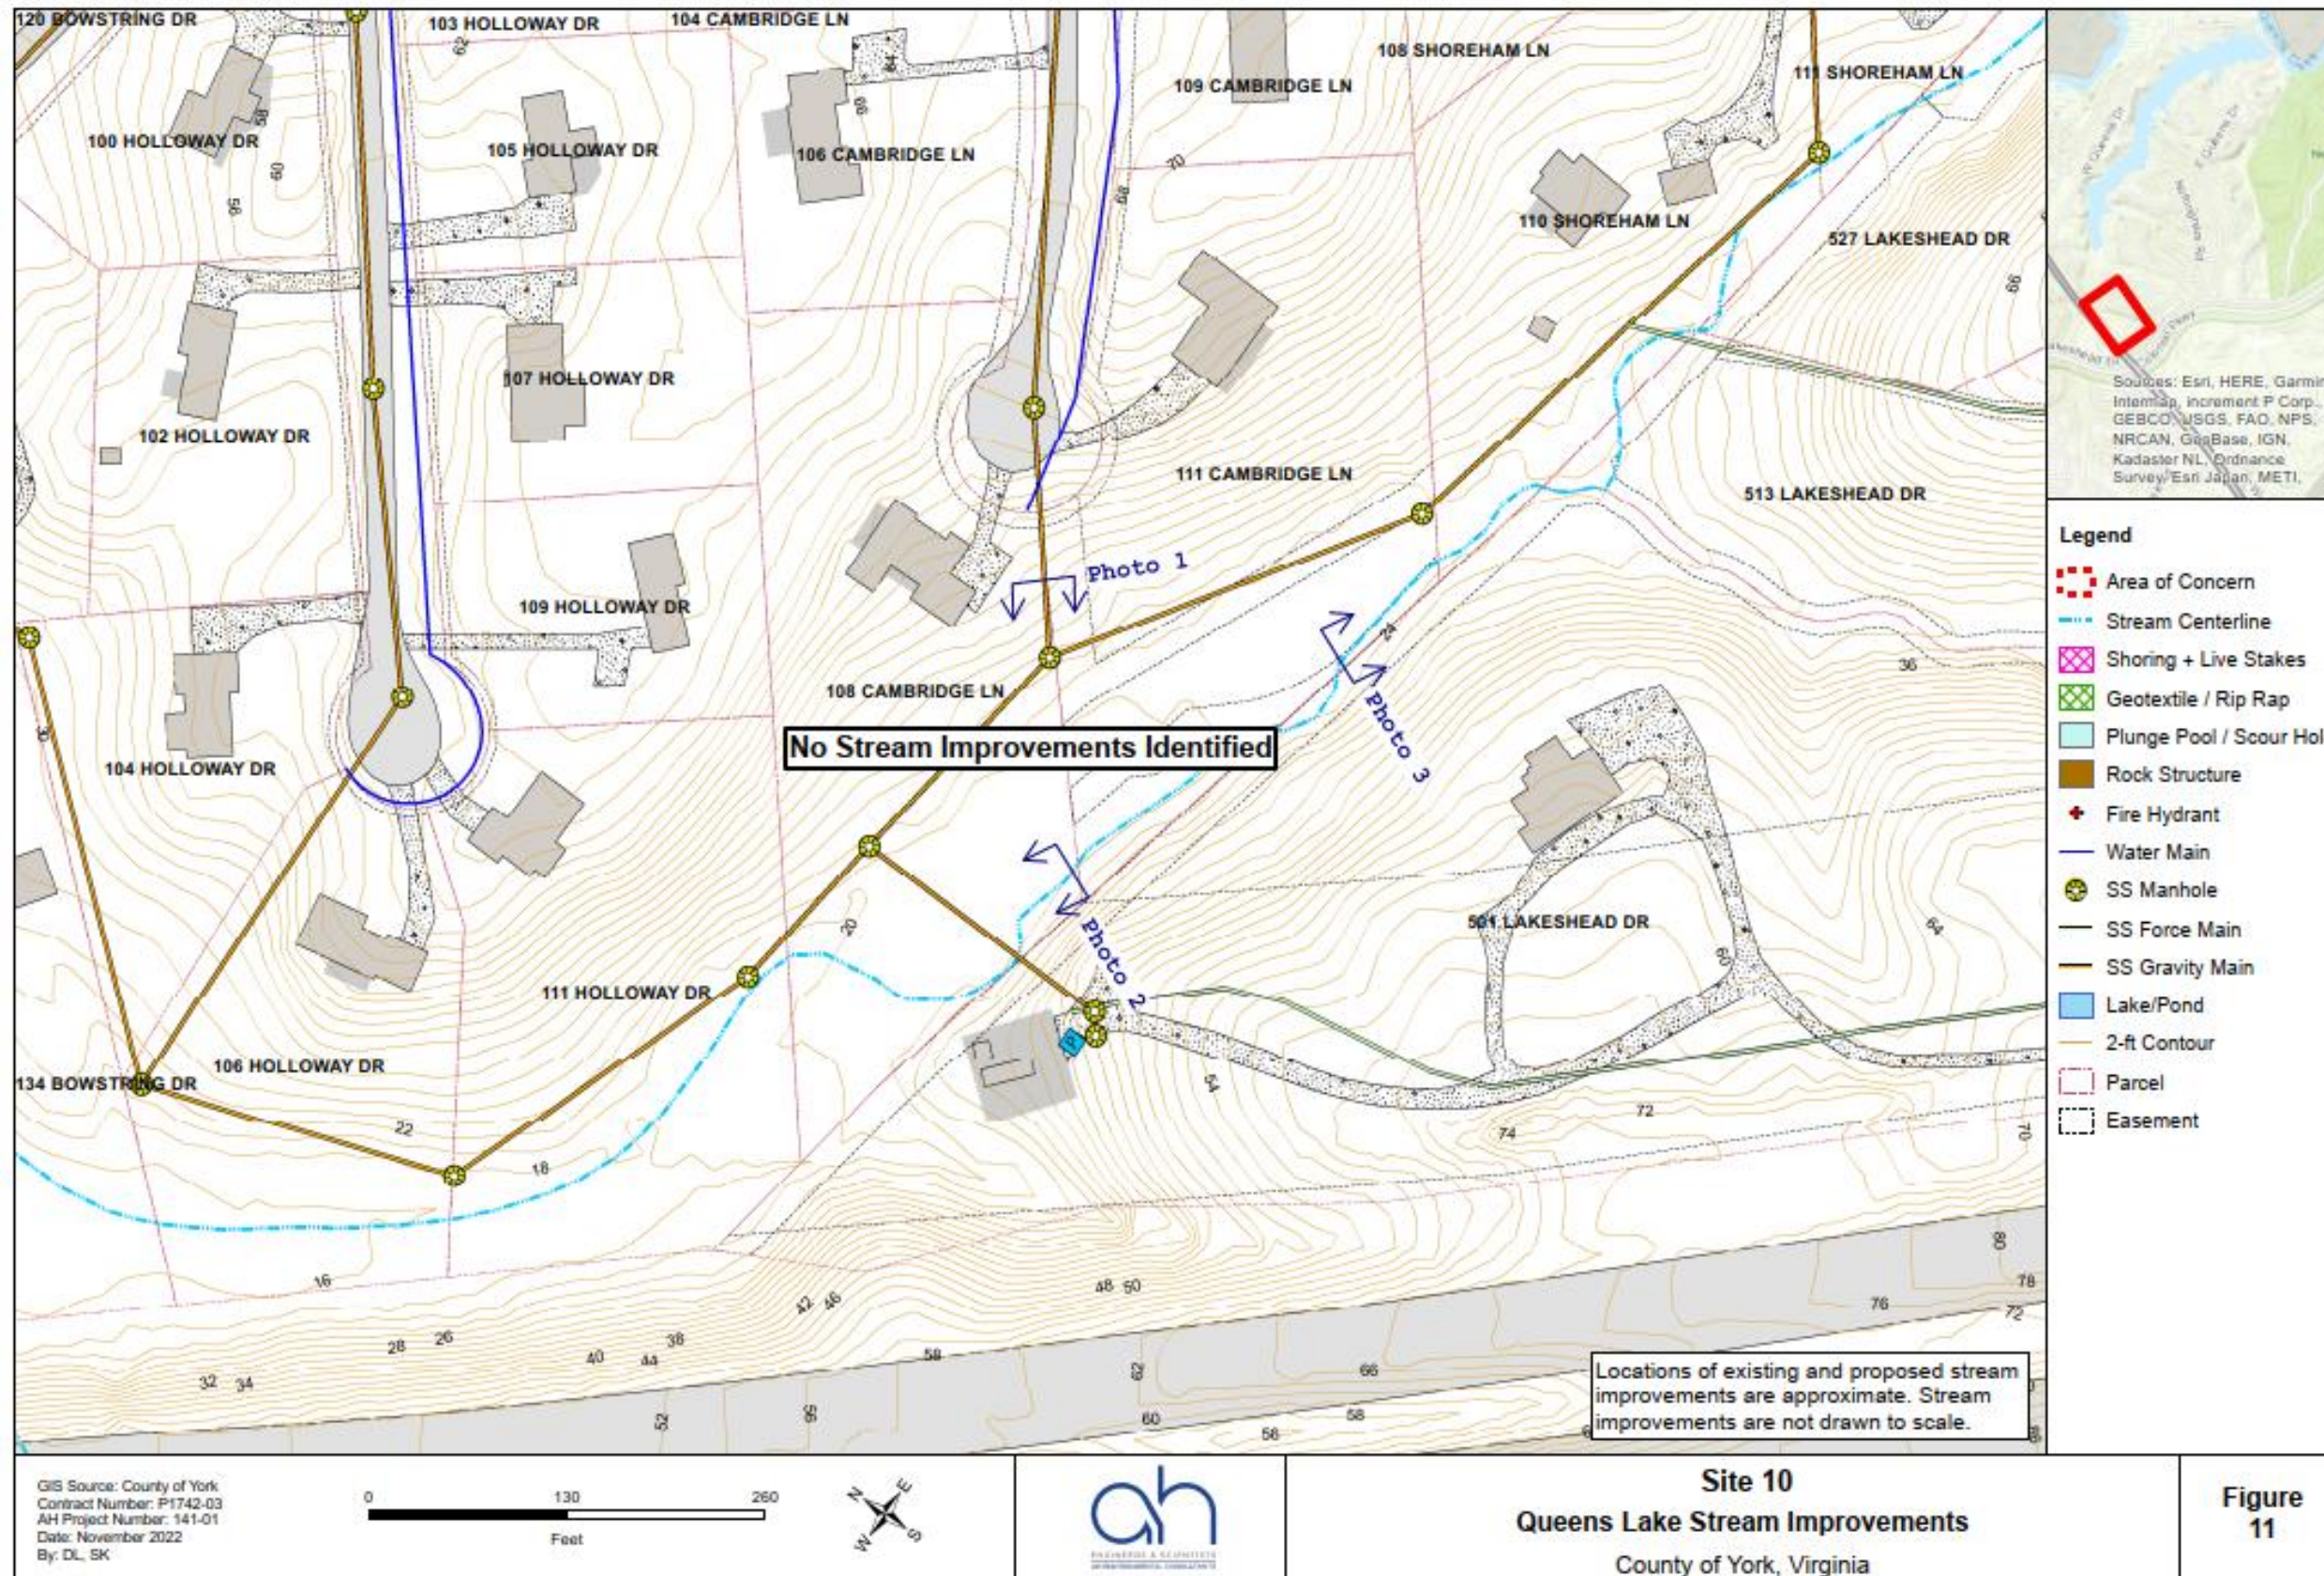
Site 10, located southwest of Cambridge Lane, was observed to be in adequate condition; no recommended improvements are offered. **Section 3.10.1** provides Site 10 photographs capturing current conditions.

**Figure 11** identifies the primary areas of concern and location of photographs. Site 10 requires no restoration activities.

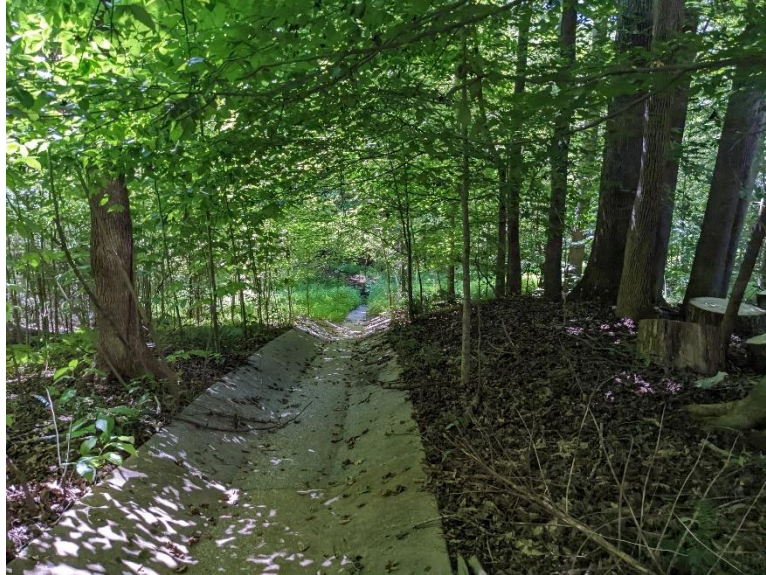
**Site 10, Photo 1: Concrete Swale from Cambridge Lane (Looking Downstream (Southwest))**
