Inspection Report

Service Date: (Inspection and Water Sample)	July 3, 2024
Service Technician:	Corey James
Contract Information:	(804) 516-5482 corey@edgewater-aes.com
Areas Inspected: (Entire Waterbody)	1) Small Pond (141 Little Jon Rd.) 2) Large Lake (231 W Queens Dr.)
Property Name:	Queens Lake
Property Contact:	Douglas Ellis (Lake Director) (757) 817-4151 qlcapresident24@gmail.com

Large Lake Inspection Report Summary

Small Pond Inspection Report Summary

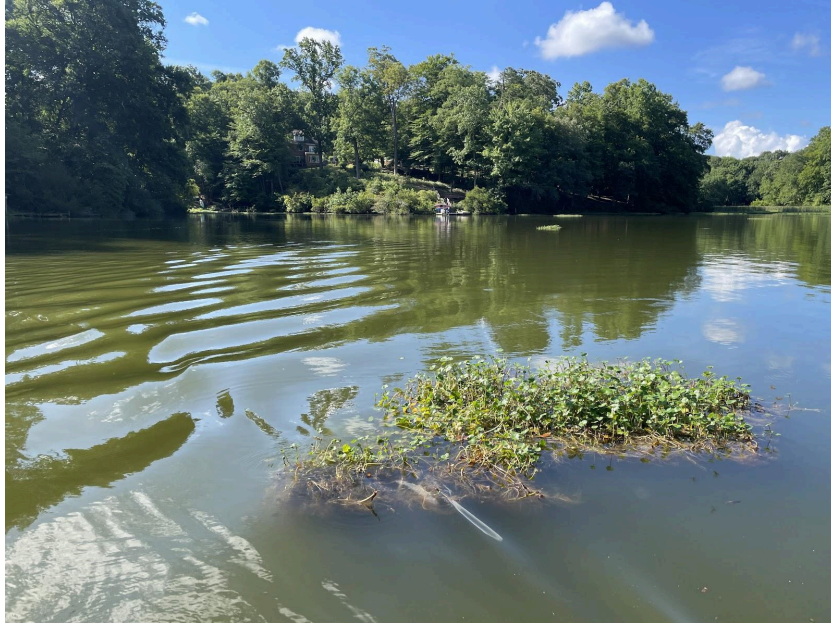
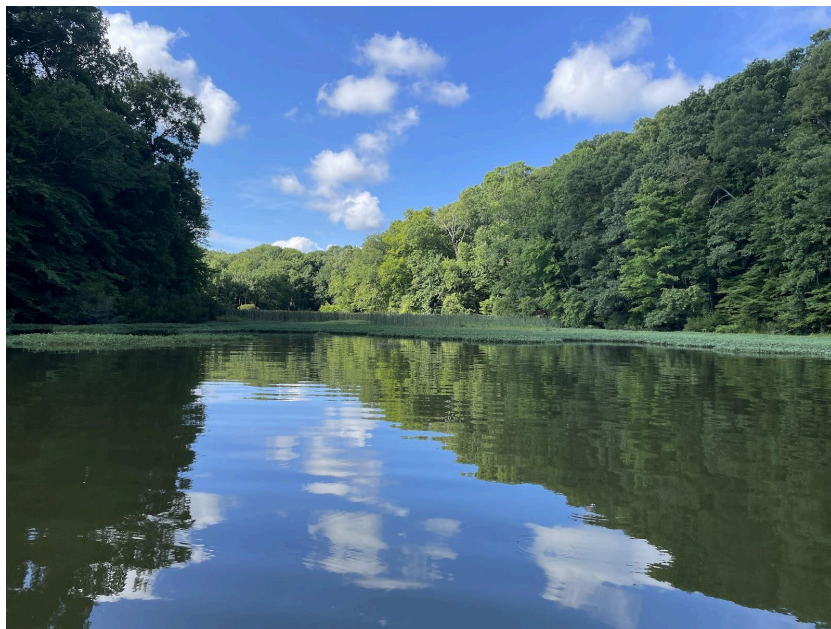
Item 2 (Note 4):

Item Number	Description	Inspection Notes
1	3 Water Samples Collected:	1) See Laboratory Report Below
2	Water Quality and Aquatic Vegetation: (Visual Inspection by boat)	1) Overall in good condition 2) Minor Planktonic Algae Growth 3) Minor Duckweed and Watermeal present on the surface 4) Water Pennywort present in several locations along the shoreline <ul style="list-style-type: none"> a) Majority of growth is located at the far end of the lake behind 143 Little John rd.) b) Several mats had broken loose and were floating in the middle of the lake 5) There is a large amount of Aquatic and woody vegetation growing around the dock and two outlet pipes at the base of the small pond dam
3	Shoreline Condition	1) Several fallen trees in the water along the shoreline 2) No major areas of erosion 3) Natural vegetation is helping to hold the shoreline and prevent erosion
4	Floating Trash	1) Minimal trash was collected from body of water

<p>Recommendation: (Not Urgent)</p>	<ol style="list-style-type: none">1) Mats are not negatively impacting the lake other than being aesthetically unpleasing and they could potentially relocate to another area and establish along the shoreline2) A quote can be provided for removing the mats mechanically using an amphibious machine.<ol style="list-style-type: none">a) Quotes will only be provided at the clients request.
---	---

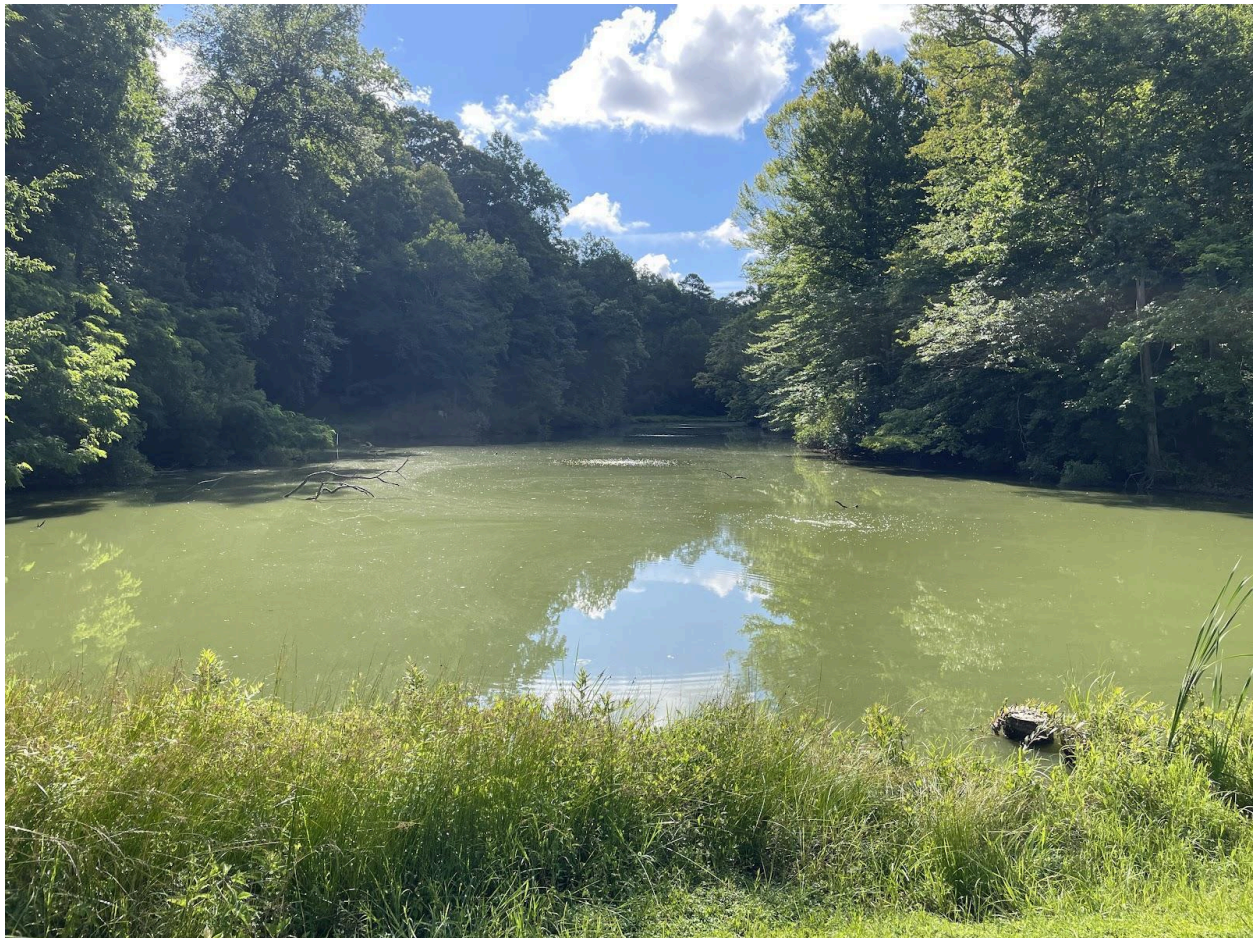
Items 2, 3, & 4 (all notes):

Item Number	Description	Inspection Notes
1	1 Water Sample Collected:	1) See Laboratory Report Below
2	Water Quality and Aquatic Vegetation: (Visual Inspection from shoreline)	1) Water quality was not as good as the lake which should be expected 2) Planktonic Algae was more prevalent than the large lake 3) Aquatic Vegetation was under control
3	Shoreline Condition	1) The shoreline was well vegetated with minimal erosion 2) There are several limbs and trees in the water and the woody vegetation is starting to encroach
4	Floating Trash	1) Minimal trash was present on the pond at the time of the inspection
5	Aeration System	1) The compressor on the shore was operating properly at the time of the inspection 2) 6 diffusers were visible from the shoreline and operating properly 3) Debris was found inside the compressor cabinet 4) The grass surrounding the cabinet is starting to grow into the ventilation grates

<p>Recommendation: (Not Urgent)</p>	<ol style="list-style-type: none">1) Fallen trees could be removed from the lake and placed on the dam to be disposed off2) Woody vegetation that is overhanging the water could be cut back and debris relocated to the dam<ol style="list-style-type: none">a) Quotes will only be provided at the clients request.
---	--
