**TO:** Joe Brogan, Chief of Stormwater Programs  
York County, Virginia  
Department of Public Works (DPW)

**FROM:** AH Environmental Consultants, Inc. (AH)

**SUBJECT:** Preliminary Assessment of Queens Lake Stream Improvements

**DATE:** 23 November 2022

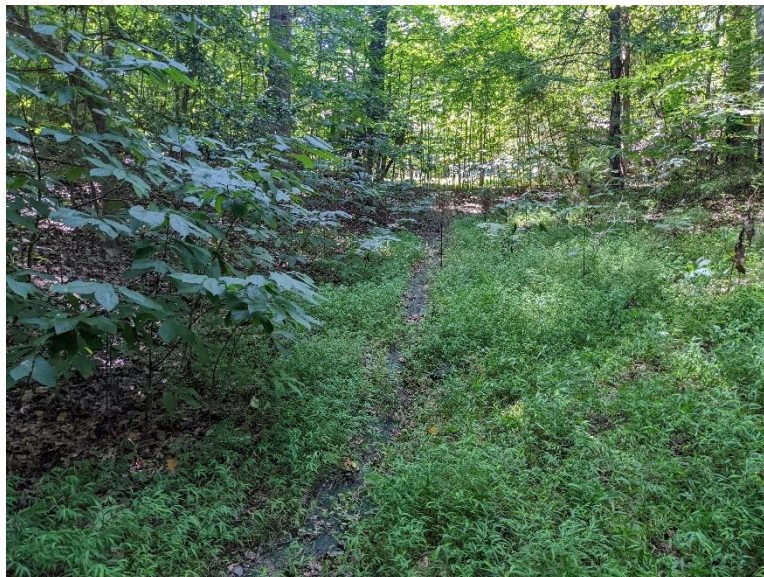
**Site 4, Photo 2: Existing Geotextile Lined Channel Continues into the Woods (Looking Downstream (East))**

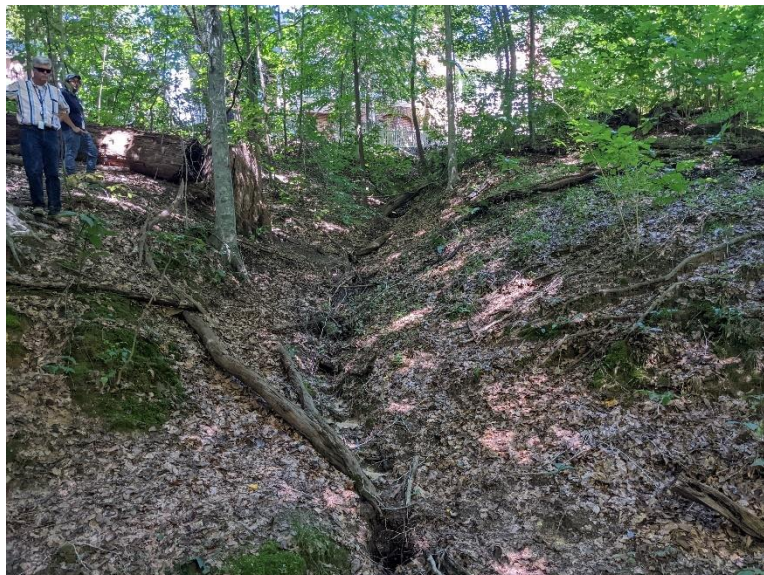
**Site 4, Photo 6: Slope Erosion behind 266 East Queens Drive (Bottom of Slope, Looking North)**

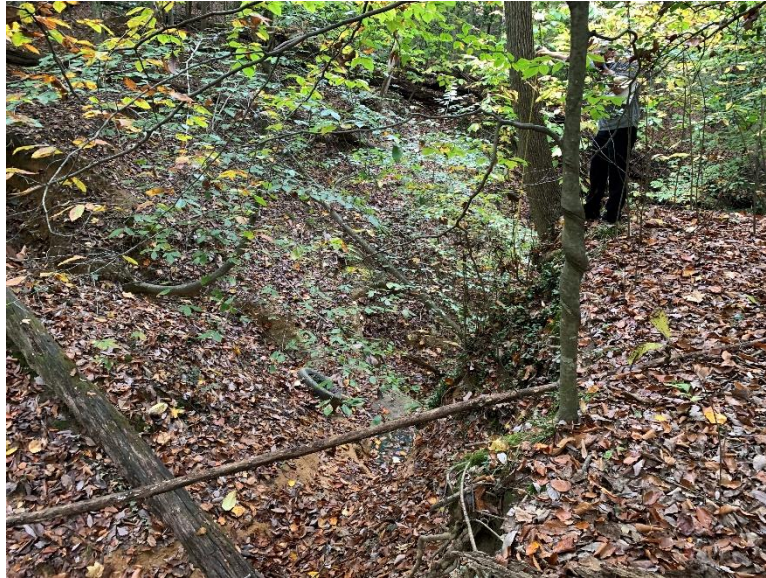
**Site 7, Photo 2: Channel Erosion Zoom-In (Looking Upstream (Southeast))**

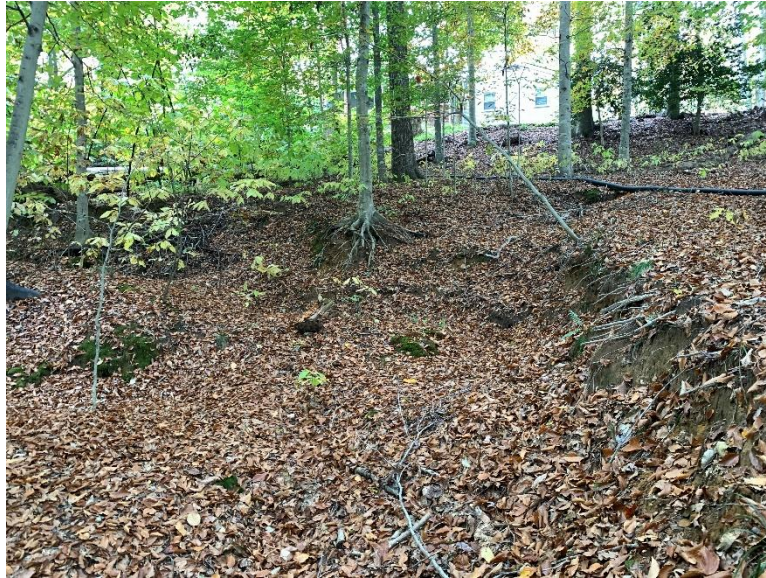
**Site 7, Photo 4: Channel Erosion (Looking Northeast)**

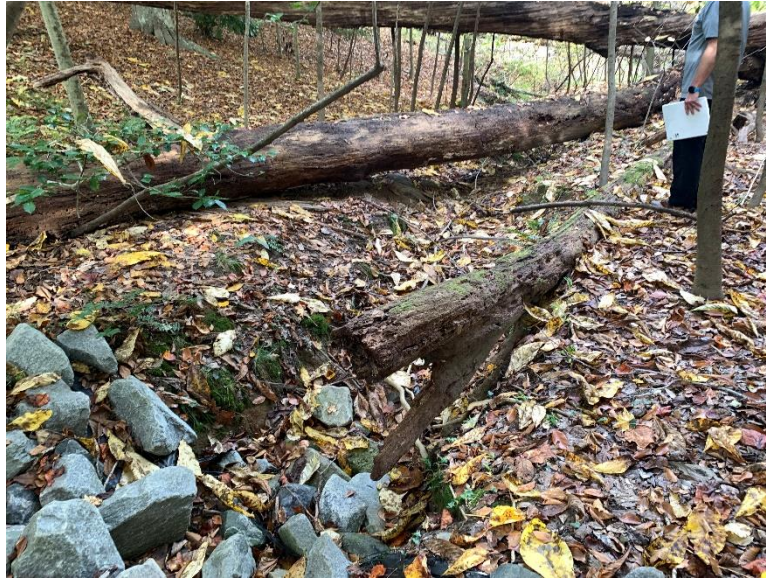
**Site 8, Photo 2: Existing Rip Rap (Looking Upstream to Copse Way)**

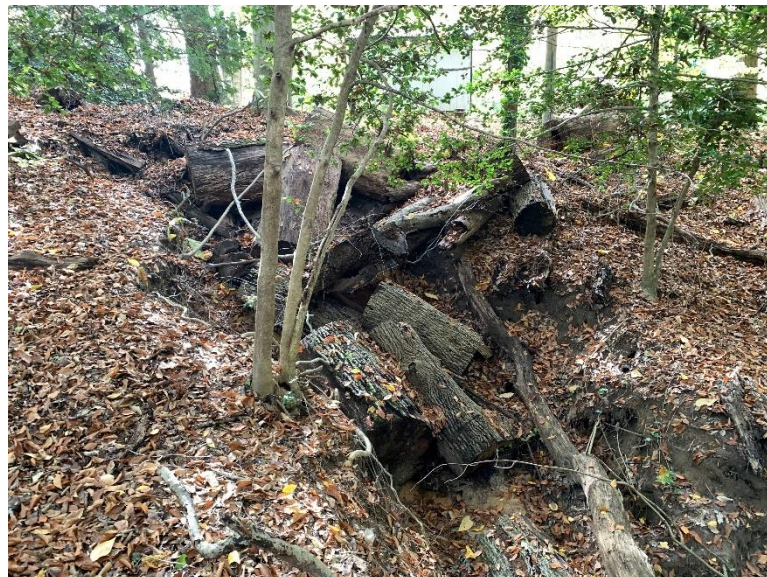
**Site 5, Photo 7: Bottom of Eroded Ditch towards 271 Princess Place (Looking Upstream (Southeast))**

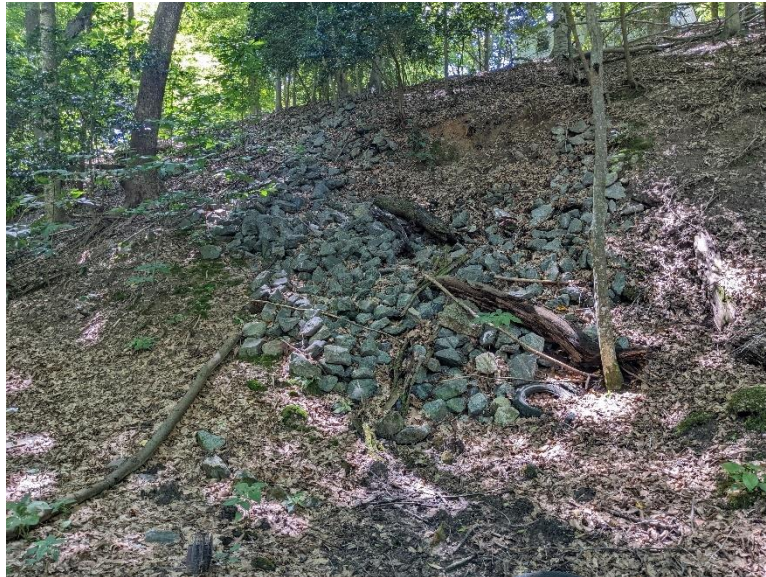
**Site 6, Photo 1: View of Stream (Looking Upstream (Southeast))**

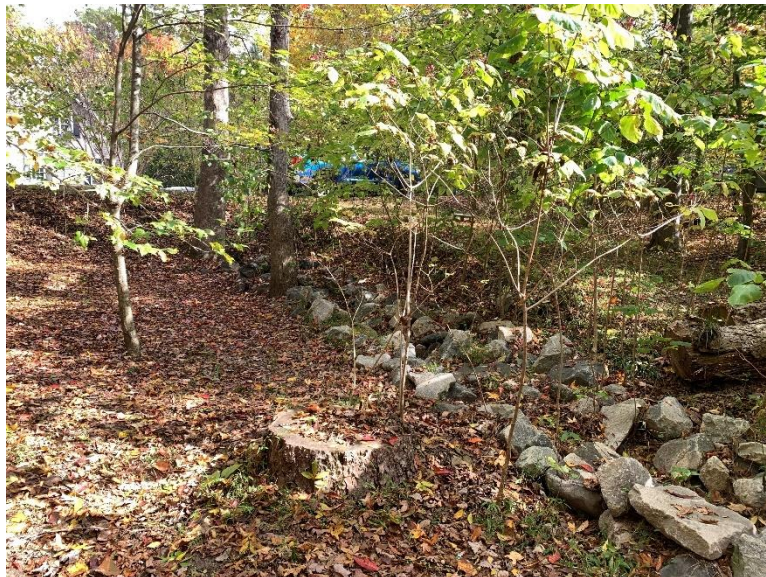
**Site 2, Photo 1: Erosion on the Northeast side of Horseshoe Drive**

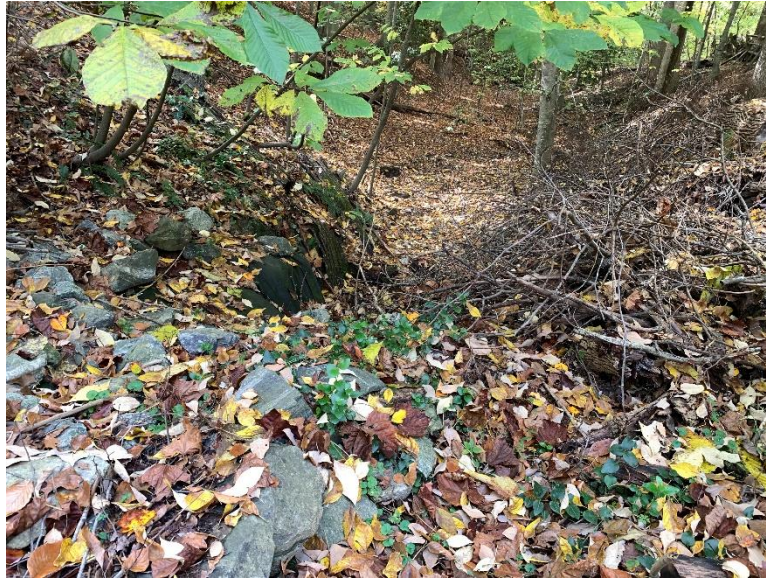
**Site 2, Photo 2: Existing Rip Rap Channel (Looking Upstream (Northeast))**

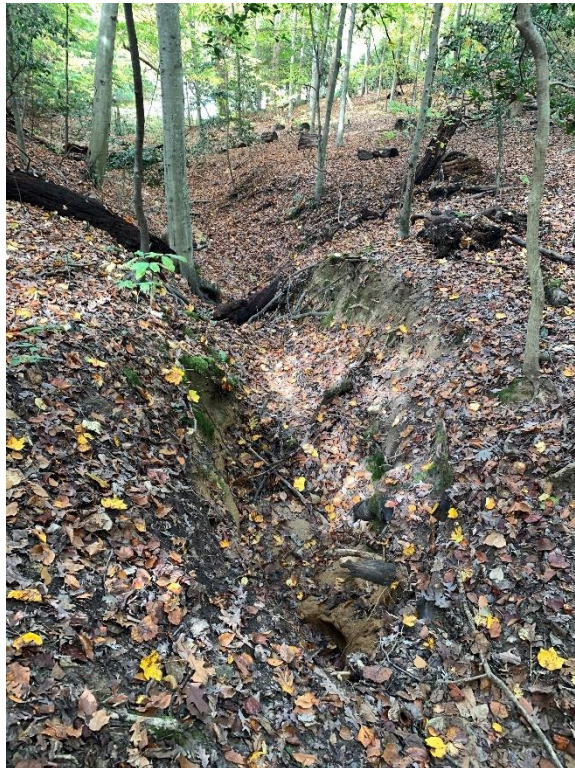
**Site 1, Photo 5: Continuation of eroded ditch (Looking Downstream (West))**

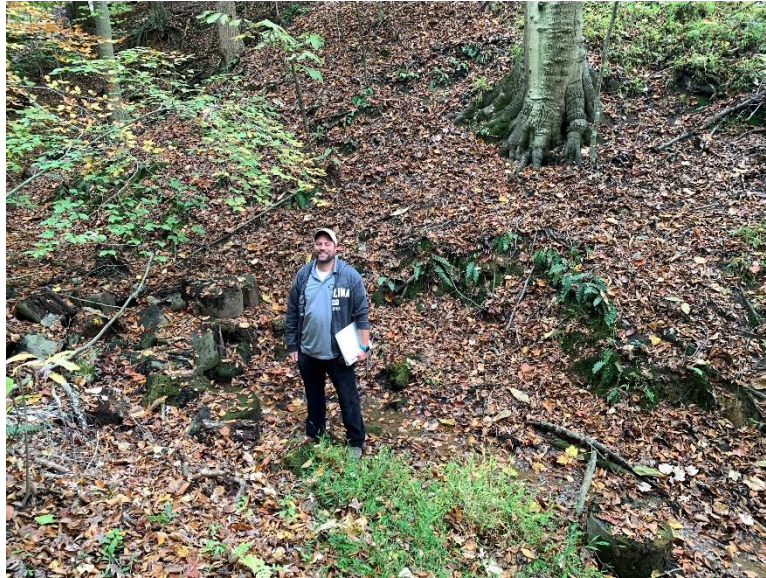
**Site 3, Photo 2: View of Stream (Looking Upstream (Southeast))**
