**TO:** Joe Brogan, Chief of Stormwater Programs  
York County, Virginia  
Department of Public Works (DPW)

**FROM:** AH Environmental Consultants, Inc. (AH)

**SUBJECT:** Preliminary Assessment of Queens Lake Stream Improvements

**DATE:** 23 November 2022

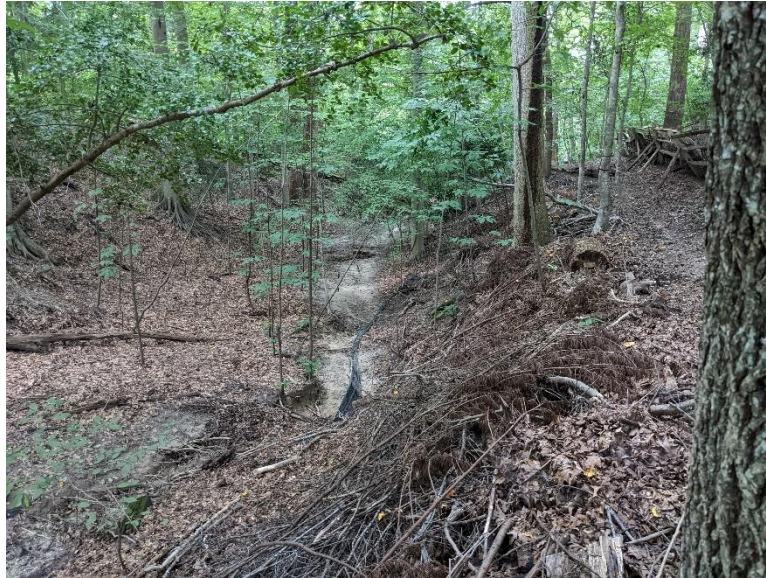
**Site 2, Photo 4: Erosion at End of Existing Rip Rap (Looking Upstream (Northeast))**

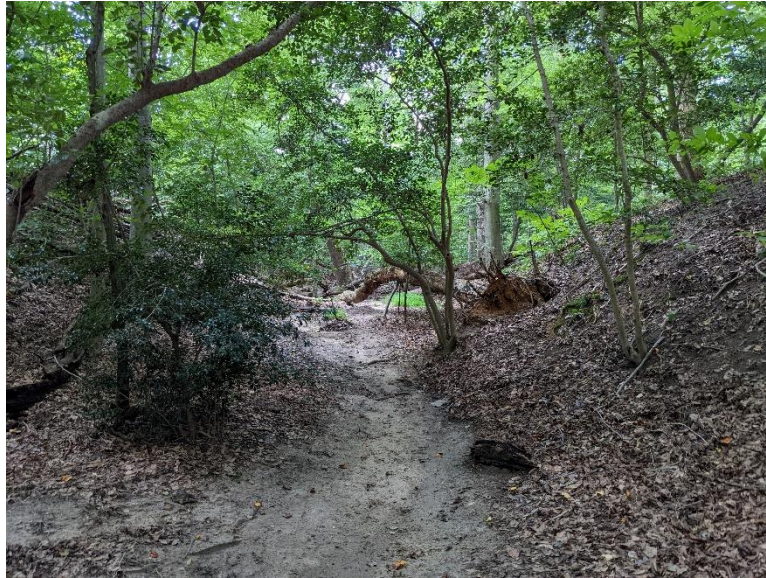
**Site 2, Photo 6: View of Channel (Looking Upstream (Northeast))**

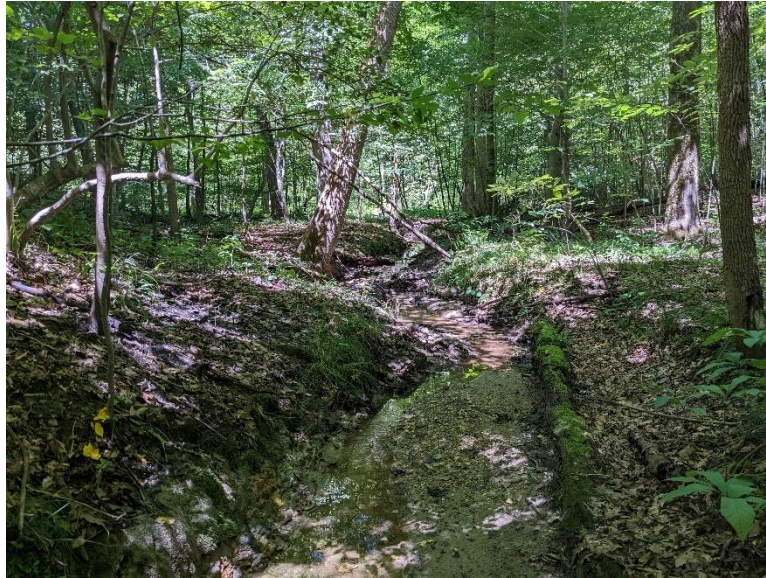
**Site 10, Photo 2: View of Stream (Looking West)**
